ASBESTOS SAMPLING MOLD Assessment

Vacant
100 Whitehaven Rd
Grand Island NY 14072

Conditions as of January 2023

Advance Contracting Services
PO Box 986
Grand Island NY 14072
advancedcss1976@gmail.com

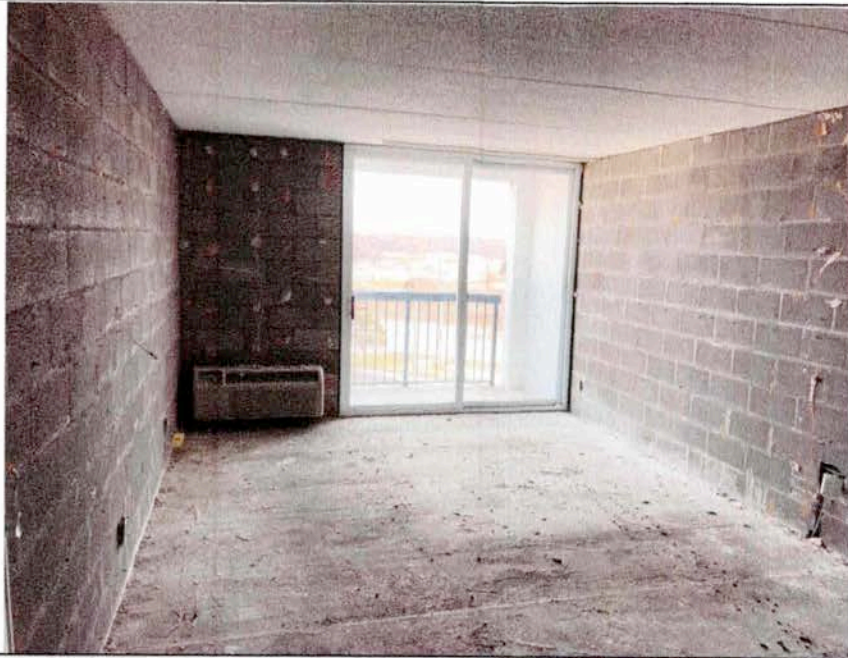
Typical Room-
Gutted

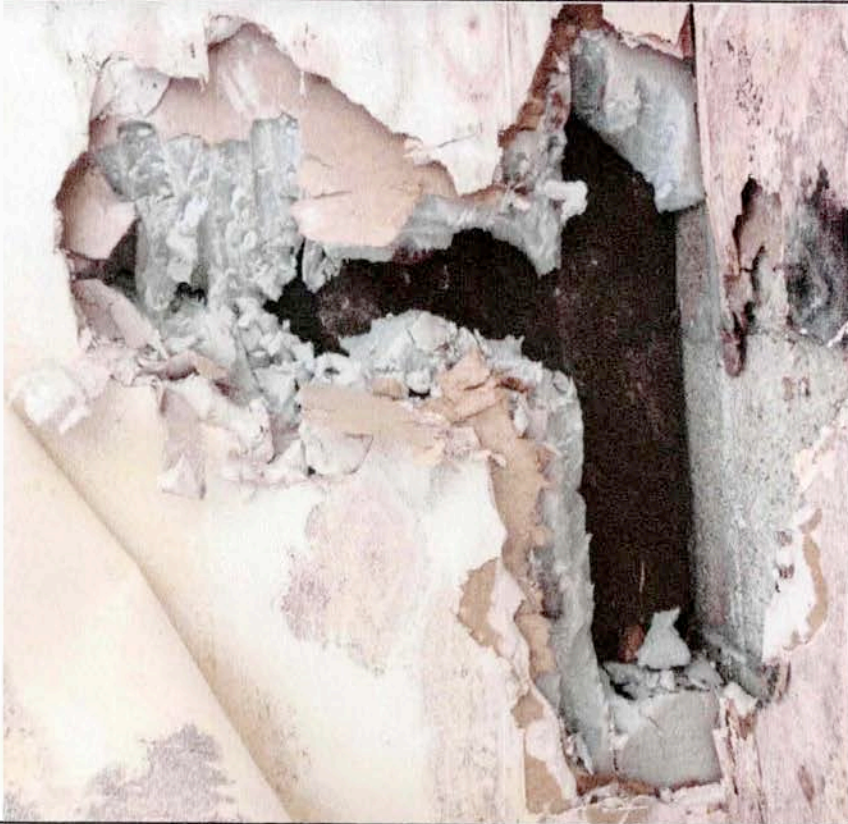
Exterior Wall is 3"
foam laminated to
exterior concrete
wall with drywall
laminated over
foam.
The exterior
concrete was wet.

Repair of exterior prior to rebuilding.

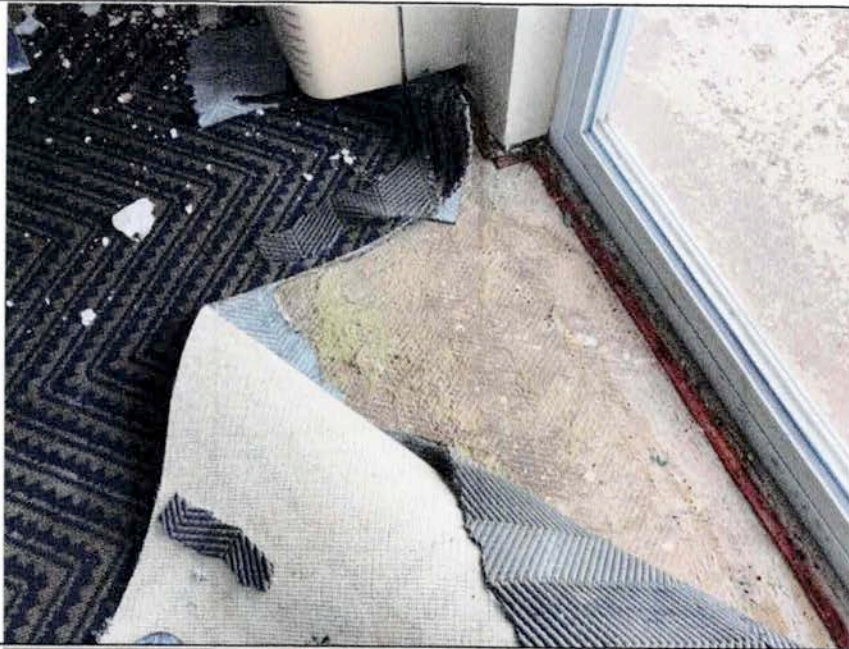
Carpet in front of exterior doorways has some mold contamination. The concrete is not a smooth finish.

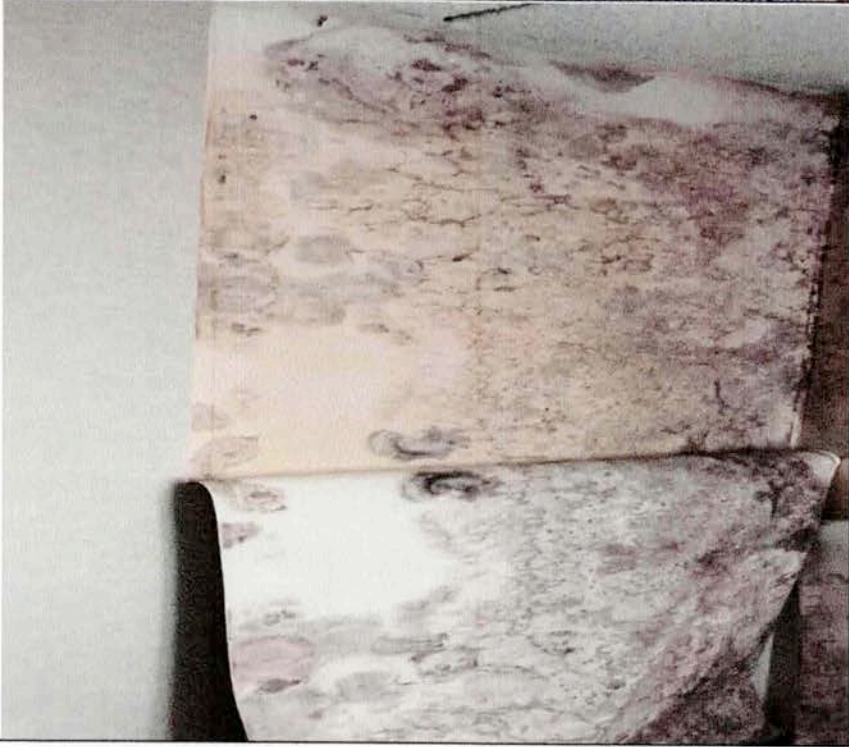
Typical Wall with mold contamination under the wallpaper

Portion of some hallways have mold growth from previous water events, the wallpaper should be peeled in all hallway areas identify any residual mold staining or growth.

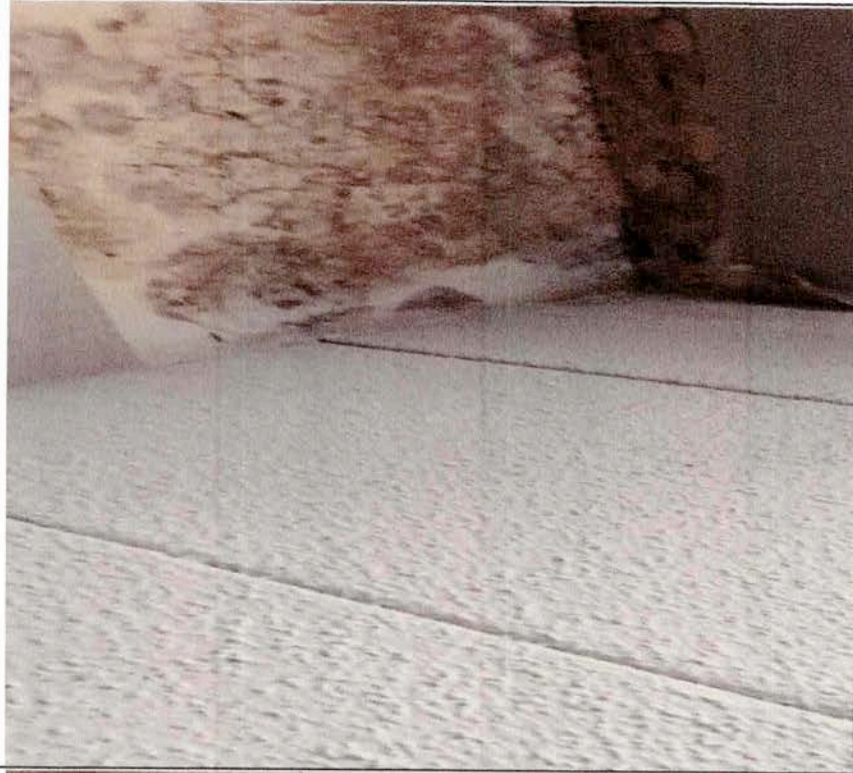
"popcorn" ceiling is
not asbestos

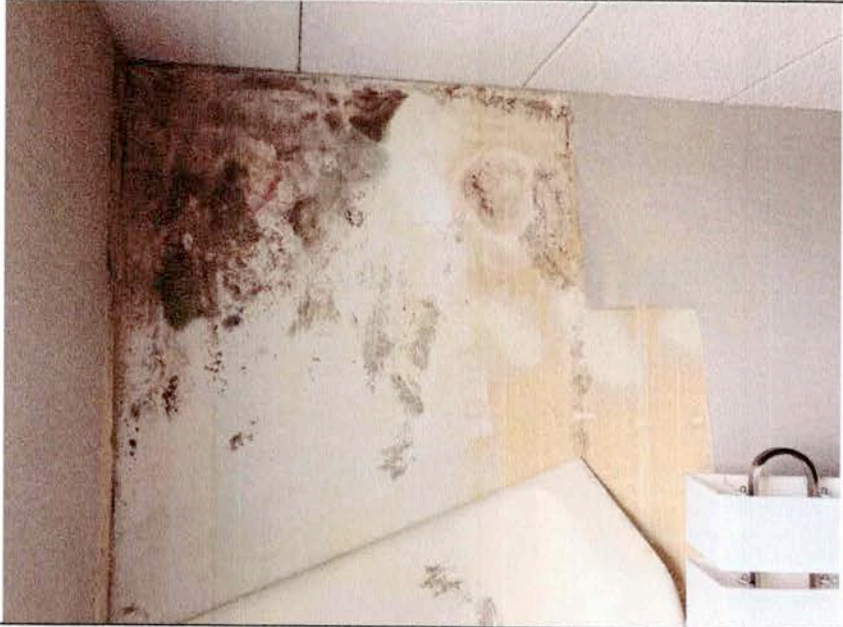
Typical room with
mold

1. Remove drywall /soft goods products with evidence of microbial growth. Clean/treat floor using an EPA registered sanitizer/disinfectant. Treat wood studs to remain with an EPA registered antimicrobial encapsulant, white or clear in color. All flat/horizontal floor/wall surfaces or previously wetted surfaces should be HEPA vacuumed and wet wiped (including, but not limited to concrete floors/walls, remaining studs, mechanical equipment, etc.

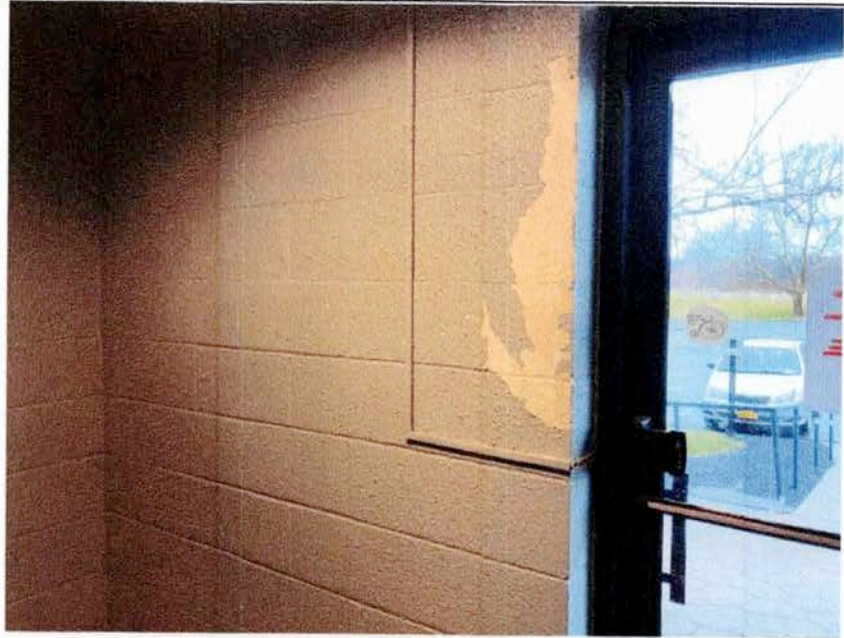
Wall paint with
vermiculite is not
asbestos.

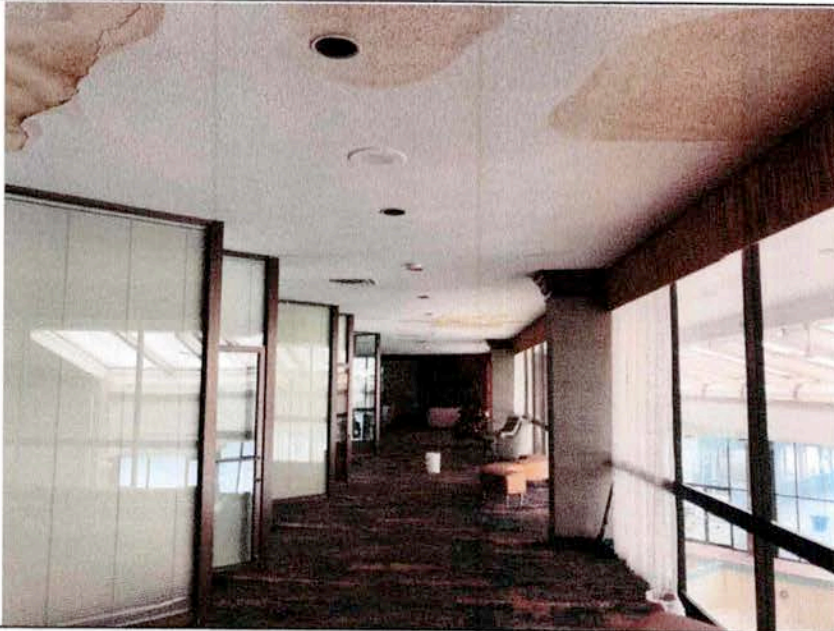
Hallway Ceiling
Non-Asbestos
