ASBESTOS SAMPLING MOLD Assessment

Vacant 100 Whitehaven Rd Grand Island NY 14072

Conditions as of January 2023

Advance Contracting Services PO Box 986 Grand Island NY 14072 advancedcss1976@gmail.com

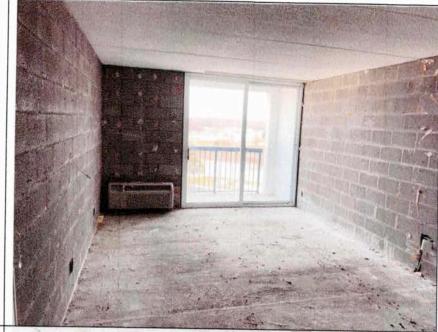
Exterior Wall is 3" foam laminated to exterior concrete wall with drywall laminated over foam.
The exterior concrete was wet.

Repair of exterior prior to rebuilding.

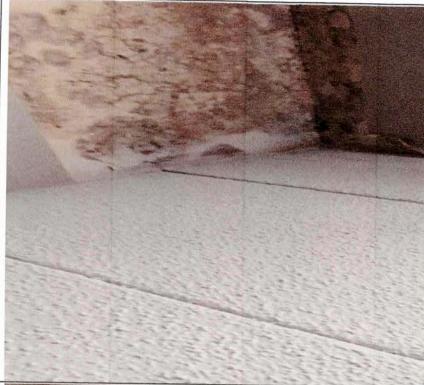
Typical room with mold

1. Remove drywall /soft goods products with evidence of microbial growth. Clean/treat floor using an EPA registered sanitizer/disinfectant. Treat wood studs to remain with an EPA registered antimicrobial encapsulant, white or clear in color. All
