Limited Pre Renovation Hazardous Materials Inspection Report

Asbestos, Lead-Based Paint, & Visual Mold

85 Humboldt Pkwy.,
Buffalo, New York 14214

Project ID: 25-0521DB-A

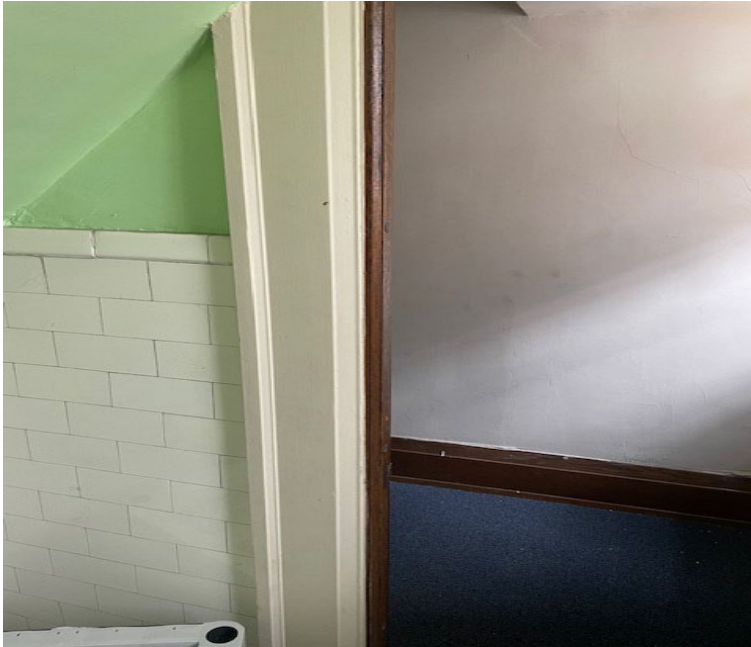
White wood Door casings were found to be covered with lead based paint on the date of inspection and in intact condition.

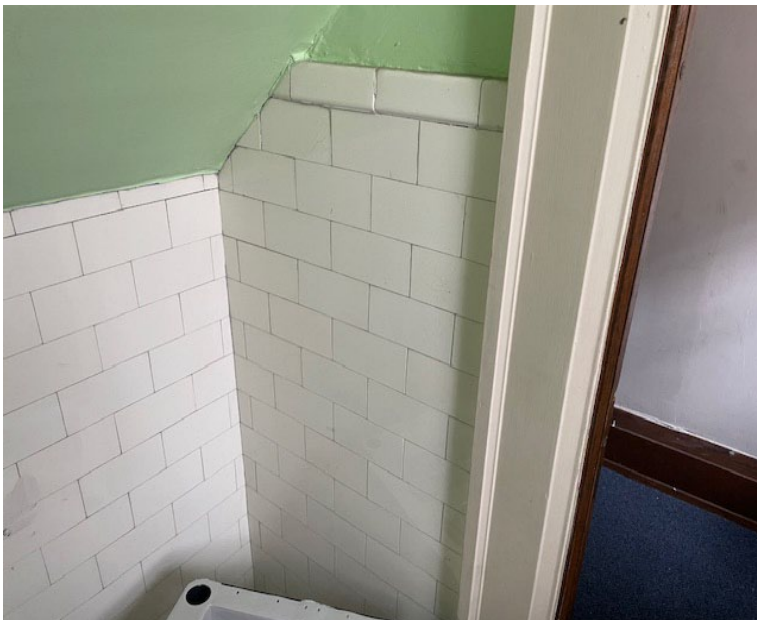
White Ceramic Tile found to be covered with lead based paint on the date of inspection and was in intact condition.

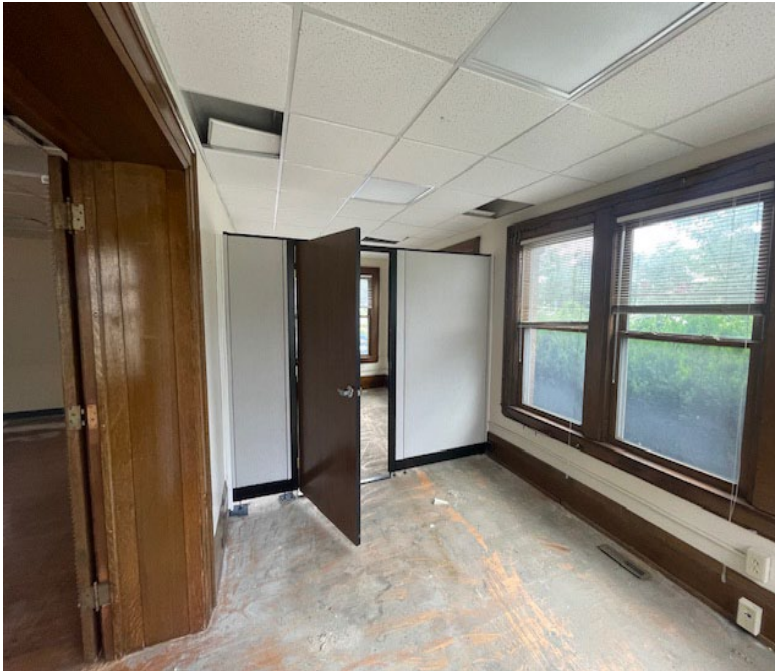
SID1008

HAN	Material Description	SID (Space Identification Number)	Estimated Quantity*	Friability/ Condition
201	Ceiling Texture -See Note 1	SID 1008 Located Above Drop Ceiling	200 SF	F/I

Overall existing conditions of the room where vermiculite was found in the textured ceiling above drop ceiling tiles.
