# Limited Pre Renovation Hazardous Materials Inspection Report

Asbestos, Lead-Based Paint, & Visual Mold

95 Humboldt Parkway,  
Buffalo, New York 14214

**Project ID:** 25-0521DB-A

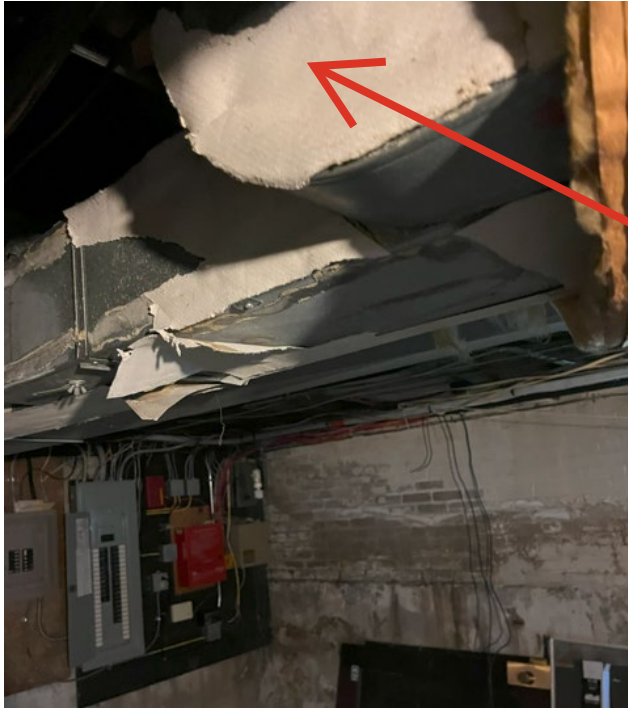
95 Humboldt – Basement

HAN	Material Description	SID (Space Identification Number)	Estimated Quantity*	Friability/ Condition
500	Duct Wrap – See Notes 1 & 2	Basement	150 SF	F/I

This material is a known asbestos containing product and predominantly found to contain asbestos when sampled; therefore, material was assumed to contain asbestos in order to save the client the expense of lab analysis for this material.

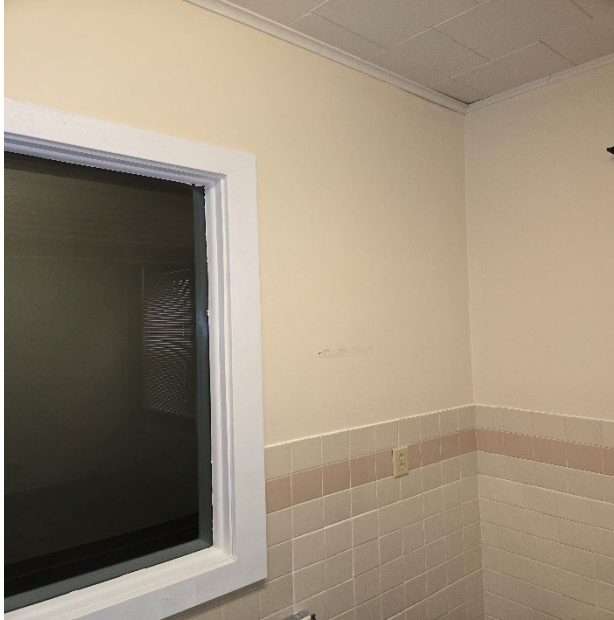
Yellow drywall walls found to be covered in lead based paint and in poor condition on the date of the inspection.

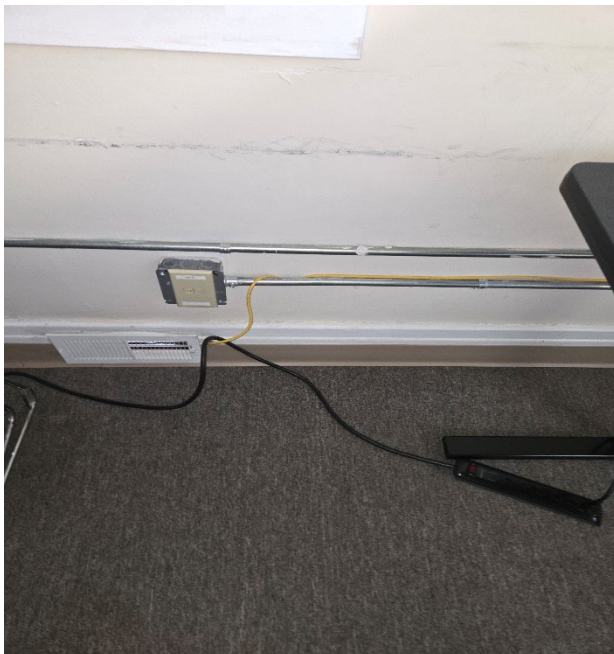
Original white wood baseboards found to be covered in lead based paint and in poor condition on the date of the inspection.
