# Limited Pre Renovation Hazardous Materials Inspection Report

Asbestos, Lead-Based Paint, & Visual Mold

117 Humboldt Parkway,  
Buffalo, New York 14214

**Project ID:** 25-0521DB-A

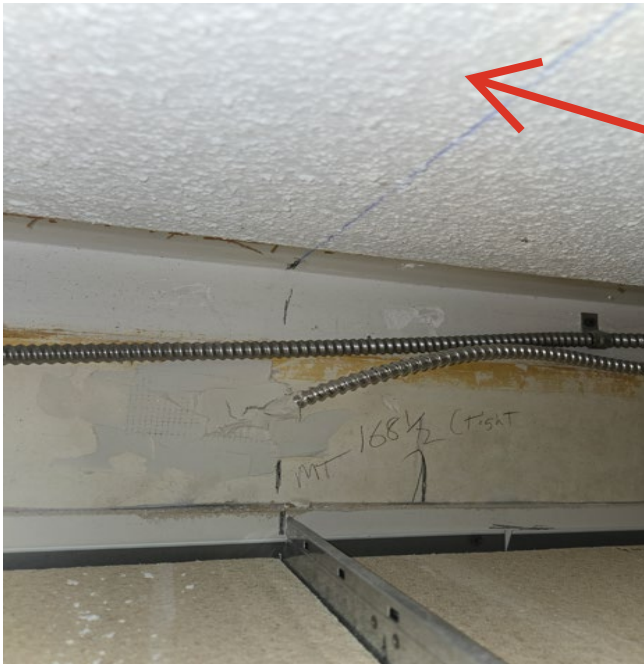
HAN201: Textured Ceiling

According to New York State Department of Health, all SM-V (surfacing material containing Vermiculite) Must be considered as an Asbestos containing material unless proven otherwise through additional lab analysis using method ELAP198.8 or equivalent.

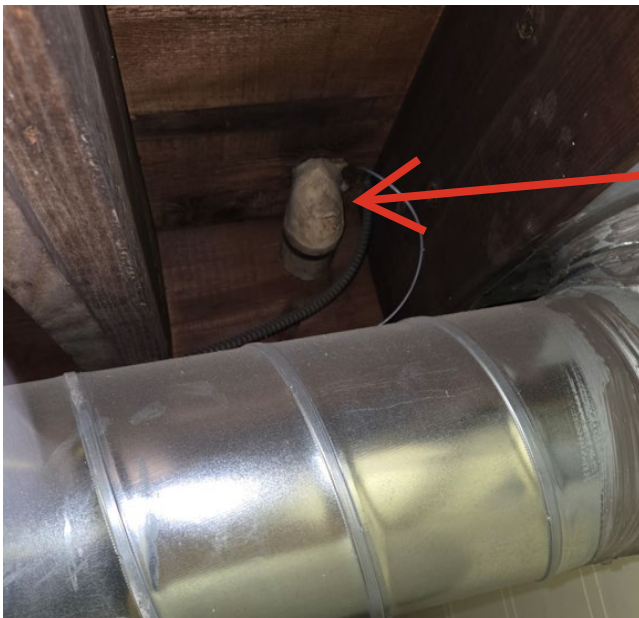
HAN400: Pipe Insulation  
HAN401: Mud Fittings

The materials are known asbestos containing products and predominantly found to contain asbestos when sampled; therefore, materials were assumed to contain asbestos in order to save the client the expense of lab analysis for these materials.

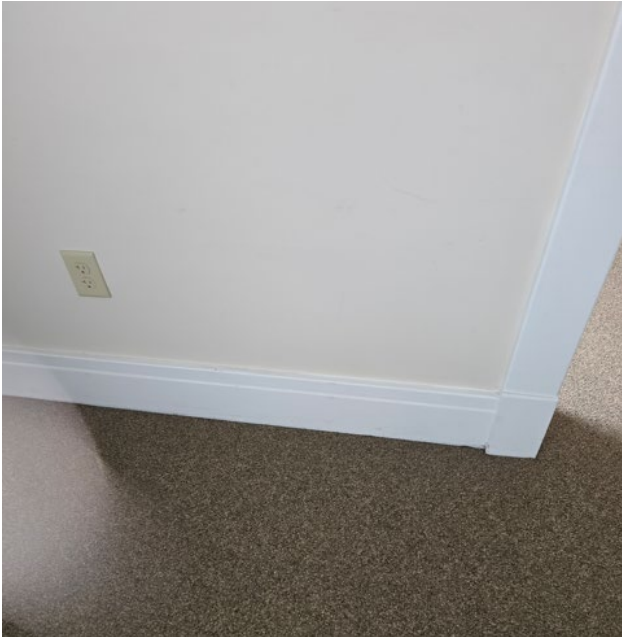
Original white wooden baseboard was found to be covered in lead based paint and in poor condition at the time of the inspection.

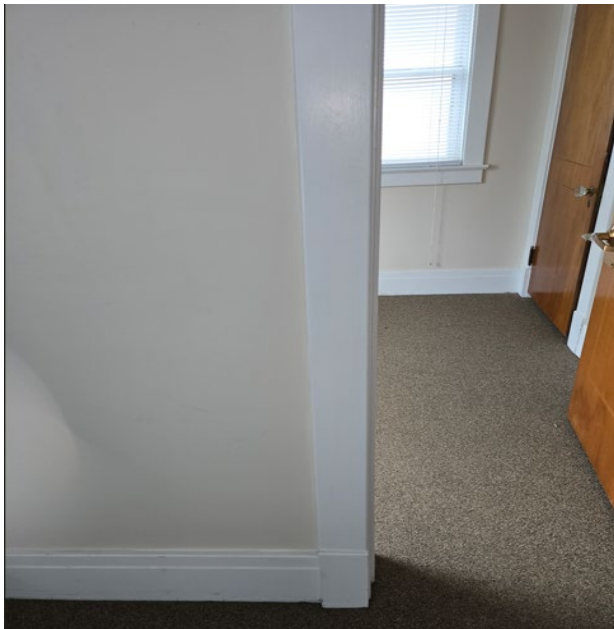
Original white wood door casing was found to be covered in lead based paint and in poor condition at the time of the inspection.

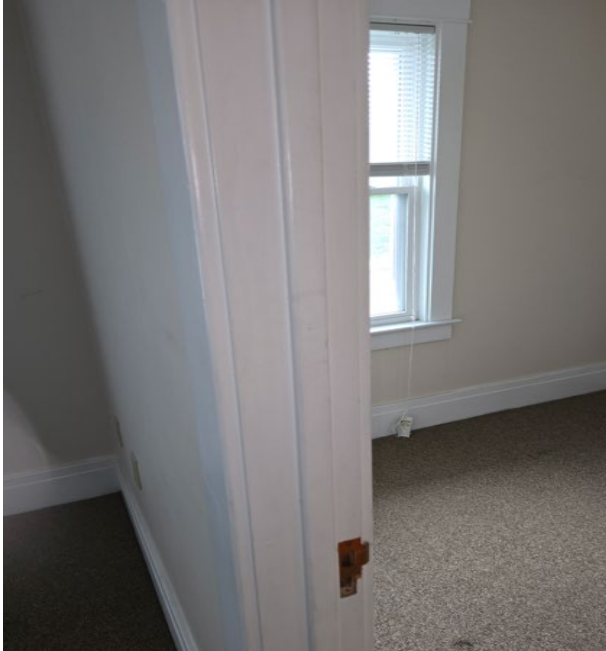
Original white wood Door components (door jamb & door stop) were found to be covered in lead based paint and in poor condition at the time of the inspection.

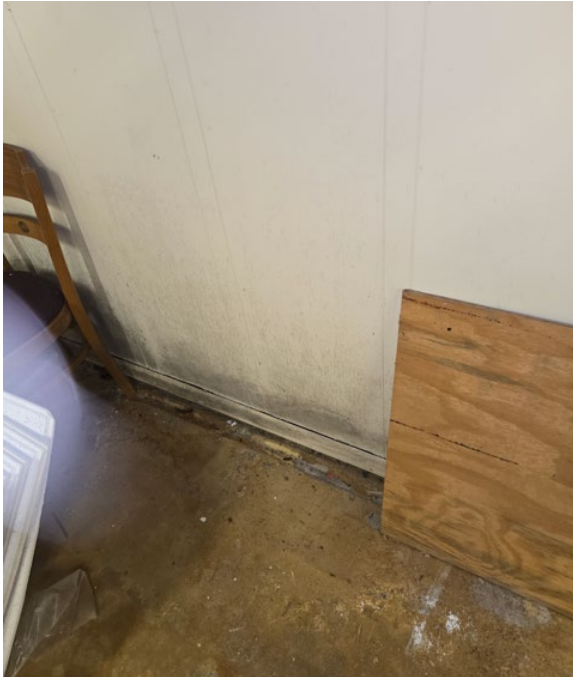
Basement Walls

- The Building has been vacant and has typical moisture intrusion at basement level without regular maintenance and preservation.

Approximately 40 SF of visible microbial growth was identified on basement walls.

It is recommended that mold mitigation in the affected areas be performed by a NYSDOL Certified Mold Mitigation Contractor for any mold on structural components such as framing, joists, foundation walls, etc. Any mold on drywall or materials that will be demolished during renovations does not require professional mitigation per NYS Article 32.

Microbial treatment should consist of specialized cleaning of all affected surfaces showing visible growth and staining with an anti-microbial detergent and seal with an anti-microbial barrier as well as HEPA vacuuming. See microbial mitigation work scope for specific procedures.

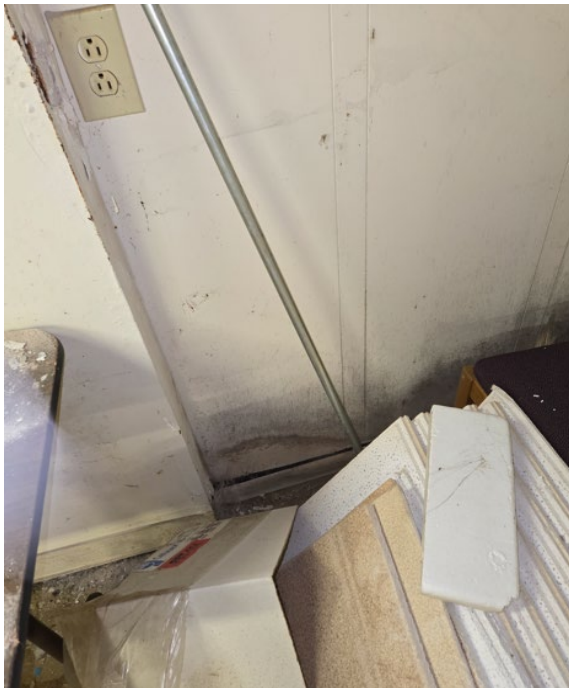
Basement Walls

Approximately 40 SF of visible microbial growth was identified on basement walls.
