# Limited Pre Renovation Hazardous Materials Inspection Report

Asbestos, Lead-Based Paint, & Visual Mold

2 Agassiz Circle,  
Buffalo, New York 14214

**Project ID:** 25-0521DB-A

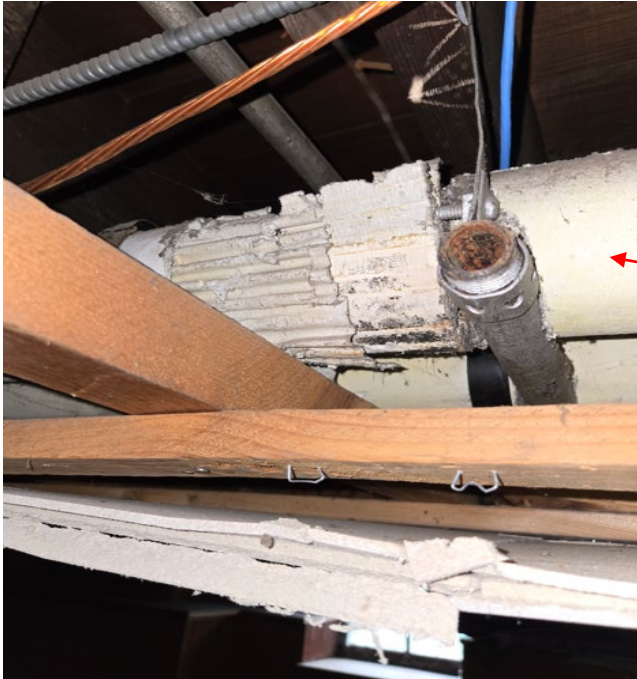
HAN400: Air Cell

This material is a known asbestos containing product and predominantly found to contain asbestos when sampled; therefore, material was assumed to contain asbestos in order to save the client the expense of lab analysis for this material.

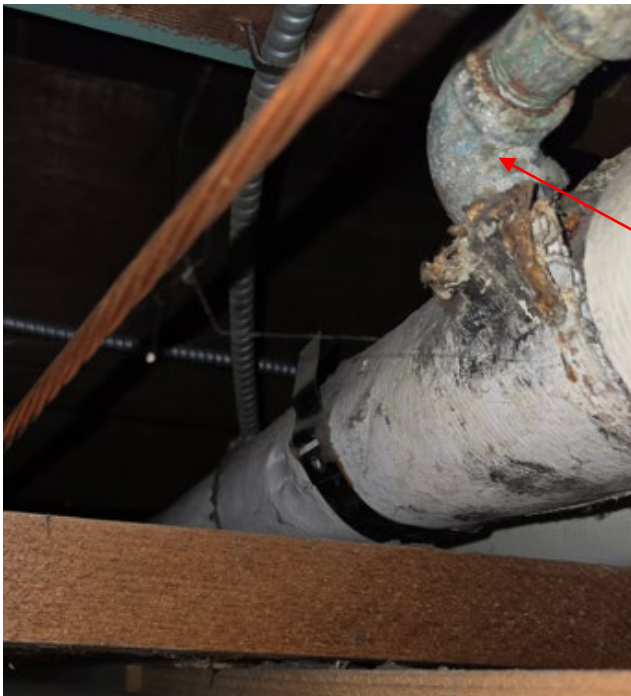
This material is a known asbestos containing product and predominantly found to contain asbestos when sampled; therefore, material was assumed to contain asbestos in order to save the client the expense of lab analysis for this material.

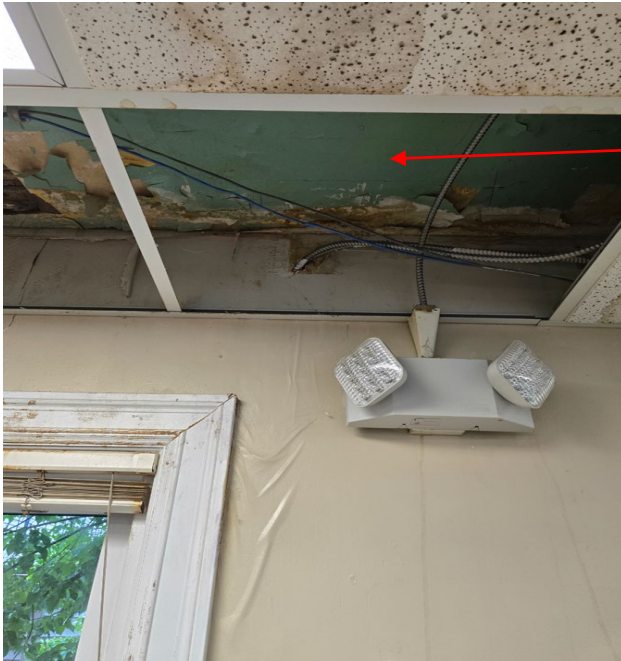
- **Original plaster ceilings found to be covered with lead based paint on the date of inspection and was in poor condition.**
- **Original painted wood baseboards were found to be covered with lead based paint on the date of inspection and was in poor condition.**

Original plaster ceiling found to be covered in lead based paint and found to be in poor condition on the date of the inspection.

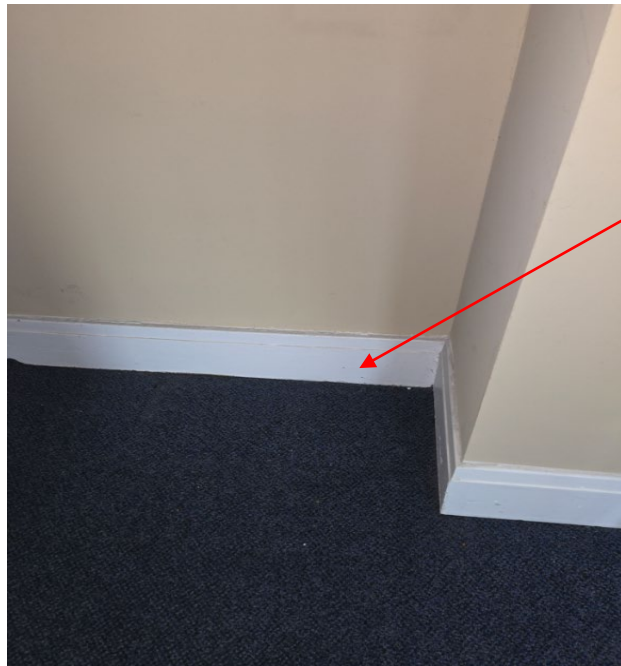
Original painted wood baseboards were found to be covered in lead based paint and were found to be in poor condition on the date of the inspection.

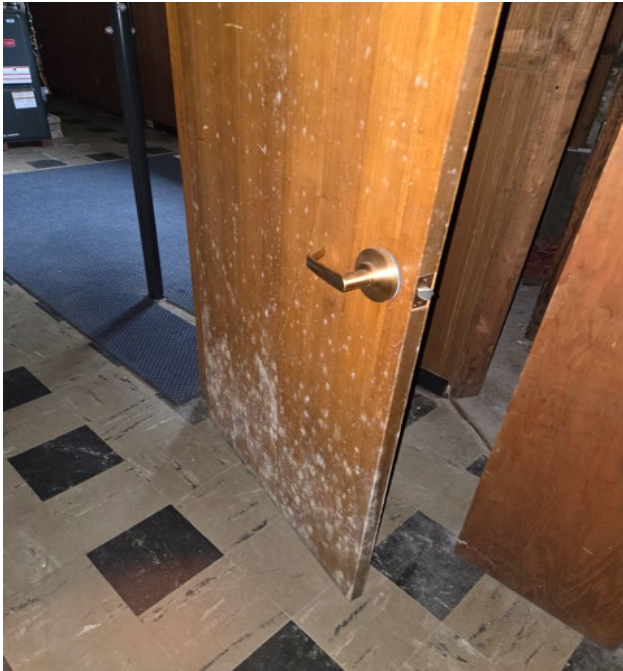
Basement – Door

Visible microbial growth was identified throughout the basement on various building components.

**It is recommended that mold mitigation in the affected areas be performed by a NYSDOL Certified Mold Mitigation Contractor for any mold on structural components such as framing, joists, foundation walls, etc. Any mold on drywall or materials that will be demolished during renovations does not require professional mitigation per NYS Article 32.**

**Microbial treatment should consist of specialized cleaning of all affected surfaces showing visible growth and staining with an anti-microbial detergent and seal with an anti-microbial barrier as well as HEPA vacuuming. See microbial mitigation work scope for specific procedures.**

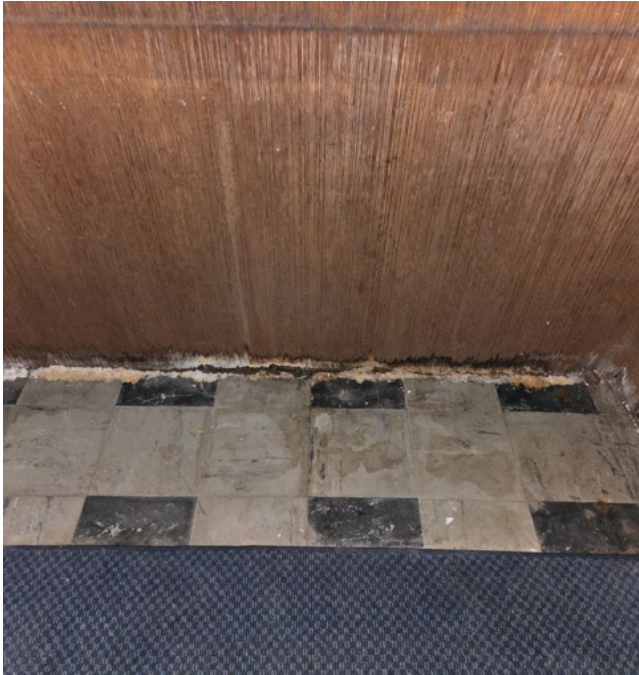
Basement – Wall Paneling

Visible microbial growth was identified throughout the basement on various building components.

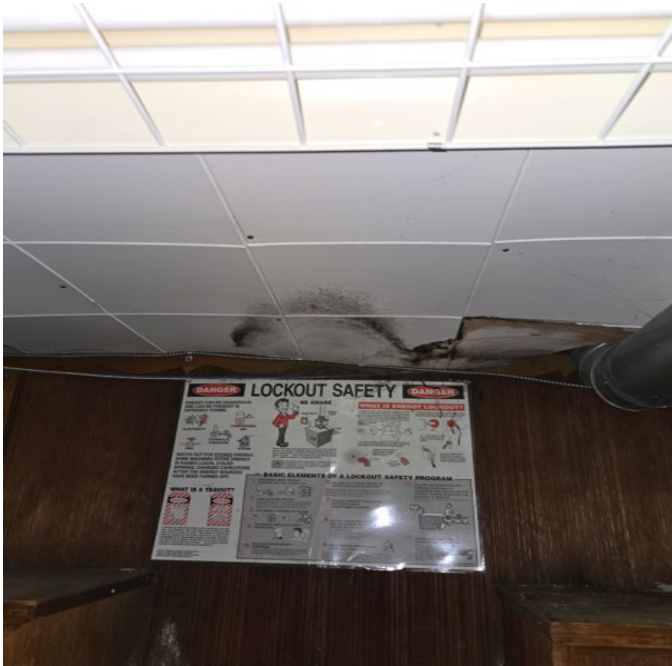
Basement – Ceiling Tile

Visible microbial growth was identified throughout the basement on various building components.
