# Limited Pre Renovation Hazardous Materials Inspection Report

Asbestos, Lead-Based Paint & Visual Mold

77 Humboldt Parkway,  
Buffalo, New York 14214

**Project ID:** 25-0521DB-A

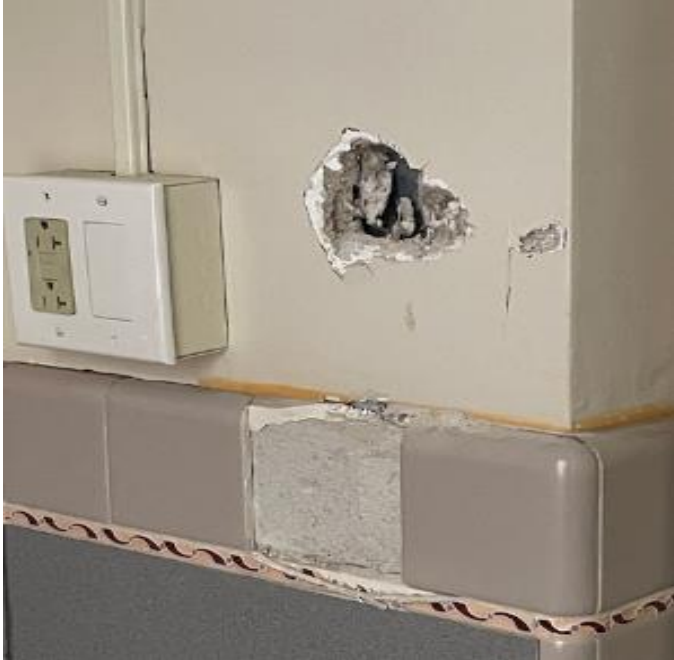
HAN100B: Base Plaster

The base plaster was found to contain vermiculite and According to the New York State Department of Health, all SM-V (surfacing material containing Vermiculite) must be considered as an Asbestos containing material(ACM), unless proven otherwise through additional lab analysis using method ELAP 198.8 or equivalent.

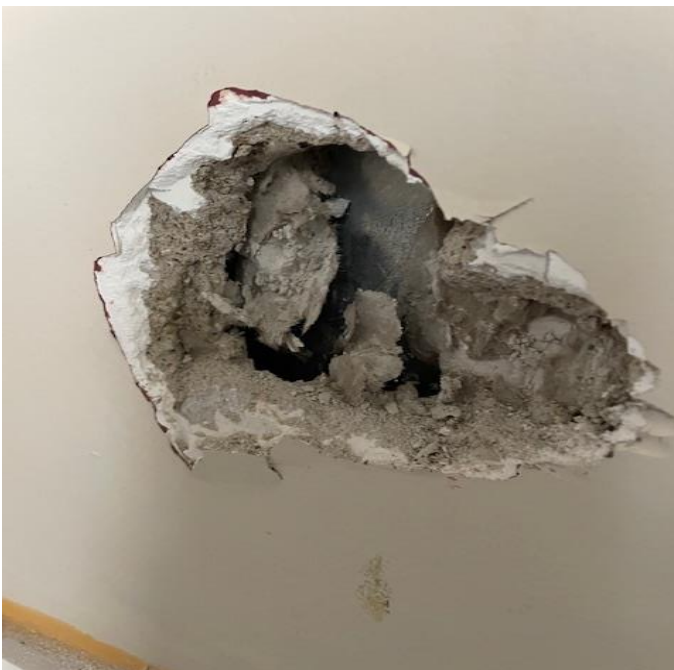
HAN100A: Skim Plaster

The material (HAN100A) was sampled and found to not contain asbestos. However, since the material (HAN100A) cannot be separated from asbestos containing materials (HAN100B) without disturbing asbestos it must be managed as such.

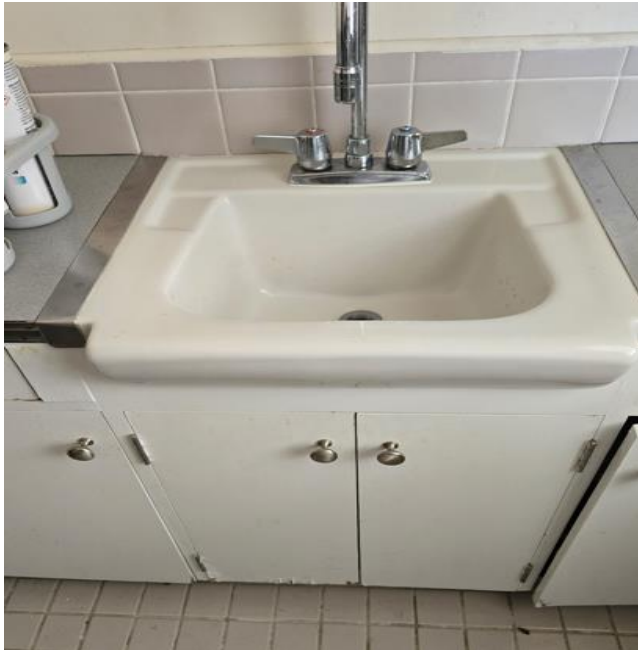
The ceramic wall tile and sink in SID 1003 were found to be covered with a lead-based coating and in intact condition at the time of inspection.

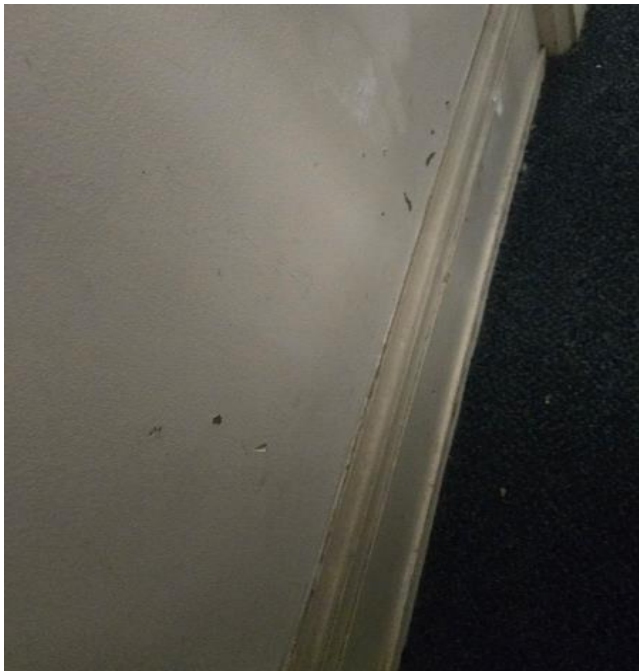
Original remaining wooden baseboards were found to be covered with lead-based paint and in poor condition at the time of inspection.

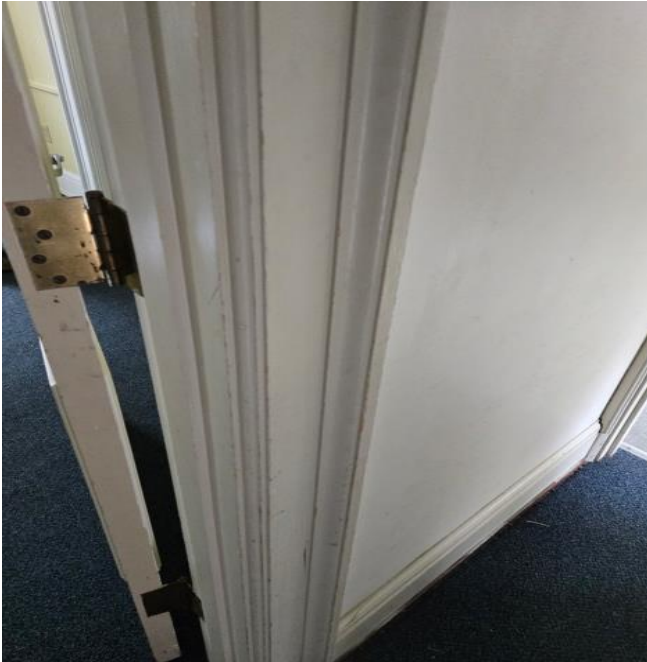
Door casing in SID 1004 was found to be covered with lead-based paint in poor condition at the time of inspection.

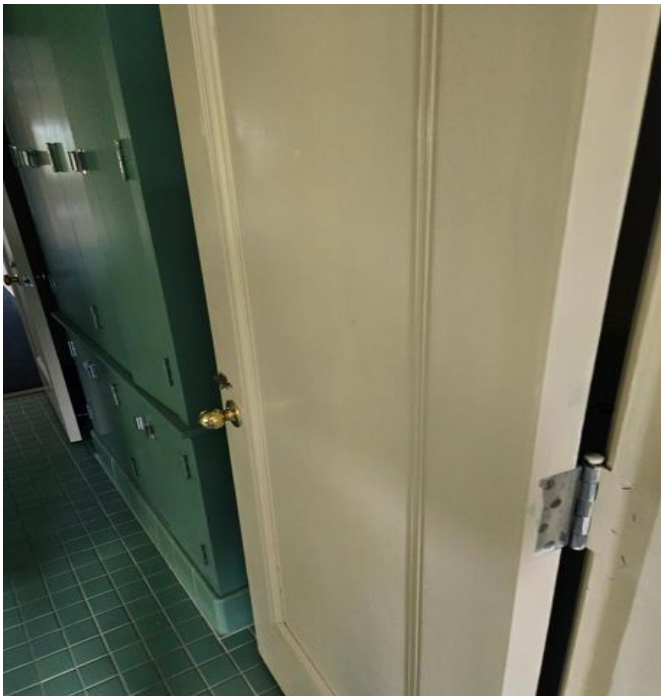
The door in SID 2000 was found to be covered with lead-based paint in poor condition at the time of inspection.

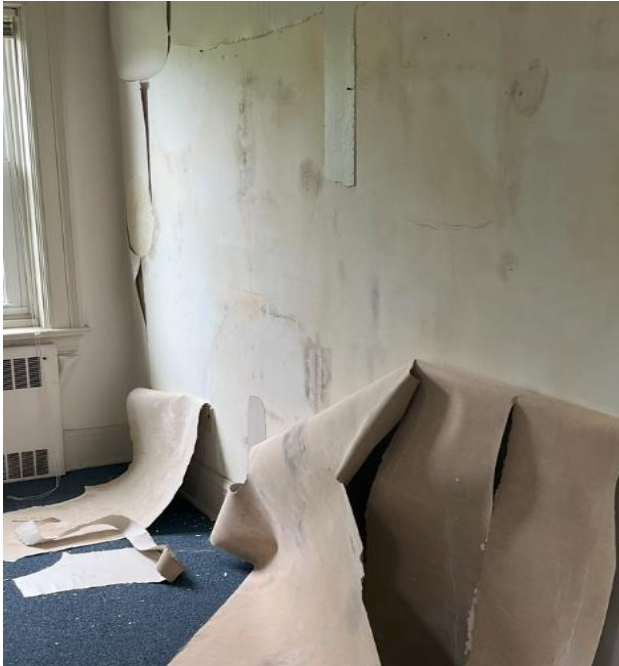
SID 2003

Visible mold growth  
identified on walls – approx.  
120 SF.

**It is recommended that mold mitigation in the affected areas be performed by a NYSDOL Certified Mold Mitigation Contractor for any mold on structural components such as framing, joists, foundation walls, etc. Any mold on drywall or materials that will be demolished during renovations does not require professional mitigation per NYS Article 32.**

**Microbial treatment should consist of specialized cleaning of all affected surfaces showing visible growth and staining with an anti-microbial detergent and seal with an anti-microbial barrier as well as HEPA vacuuming. See microbial mitigation work scope for specific procedures.**

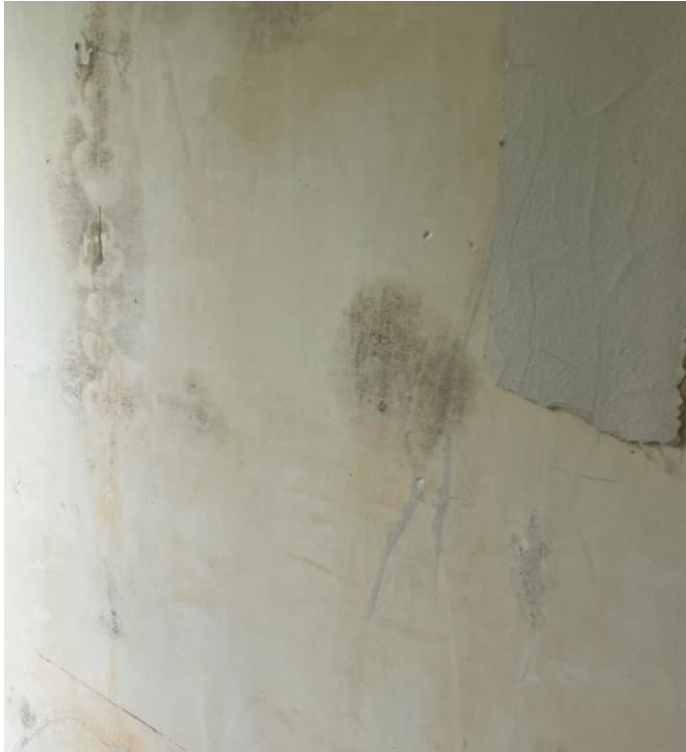
SID 2003

Visible mold growth  
identified on walls – approx.  
120 SF.
