Limited Pre Renovation Hazardous Materials Inspection Report

Asbestos, Lead-Based Paint, & Visual Mold

73 Humboldt Parkway,
Buffalo, New York 14214

Project ID: 25-0521DB-A

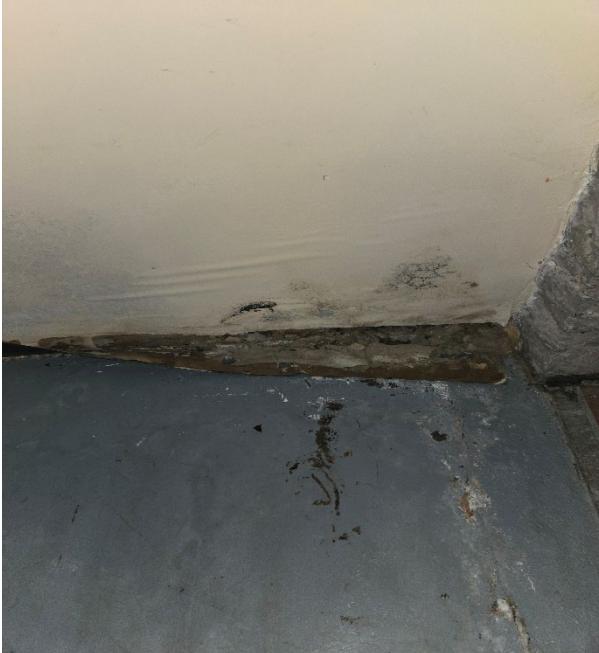
<p>Location: Basement</p> <p>Observation: Approximately 320 SF of visible microbial growth was identified on drywall walls in basement.</p>

It is recommended that mold mitigation in the affected areas be performed by a NYSDOL Certified Mold Mitigation Contractor for any mold on structural components such as framing, joists, foundation walls, etc. Any mold on drywall or materials that will be demolished during renovations does not require professional mitigation per NYS Article 32.

Microbial treatment should consist of specialized cleaning of all affected surfaces showing visible growth and staining with an anti-microbial detergent and seal with an anti-microbial barrier as well as HEPA vacuuming. See microbial mitigation work scope for specific procedures.

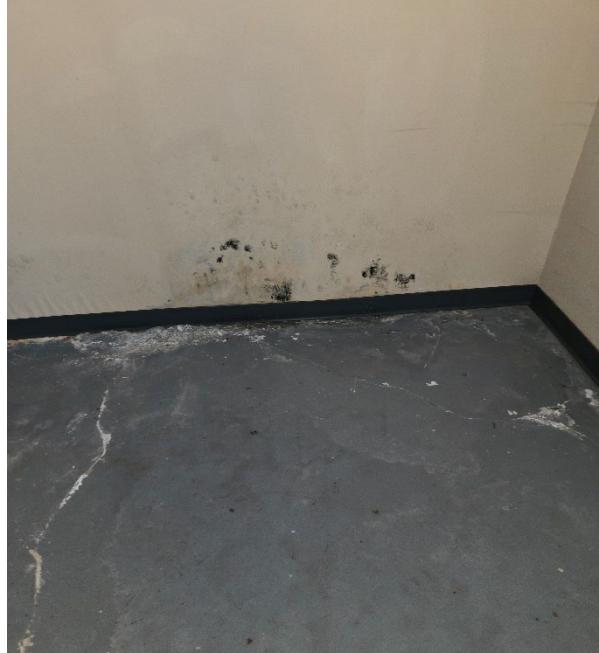
<p>Location: Basement</p> <p>Observation: Approximately 320 SF of visible microbial growth was identified on drywall walls in basement.</p>

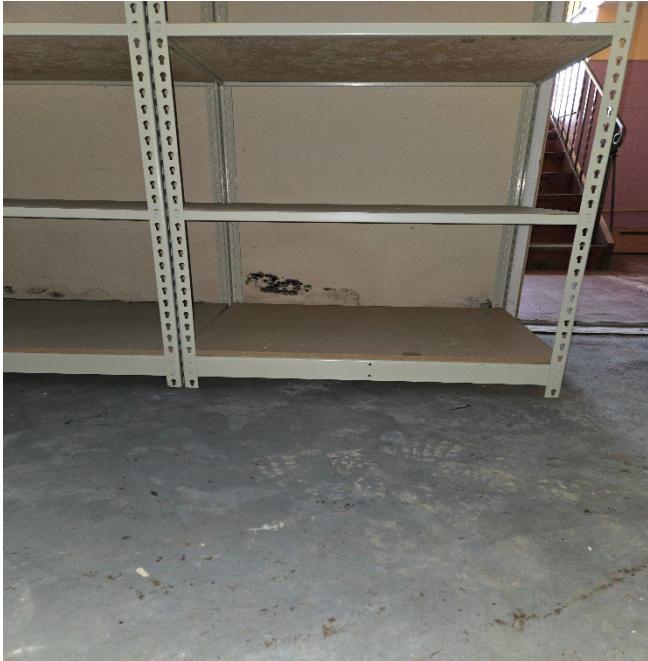
<p>Location: Basement</p> <p>Observation: Approximately 320 SF of visible microbial growth was identified on drywall walls in basement.</p>

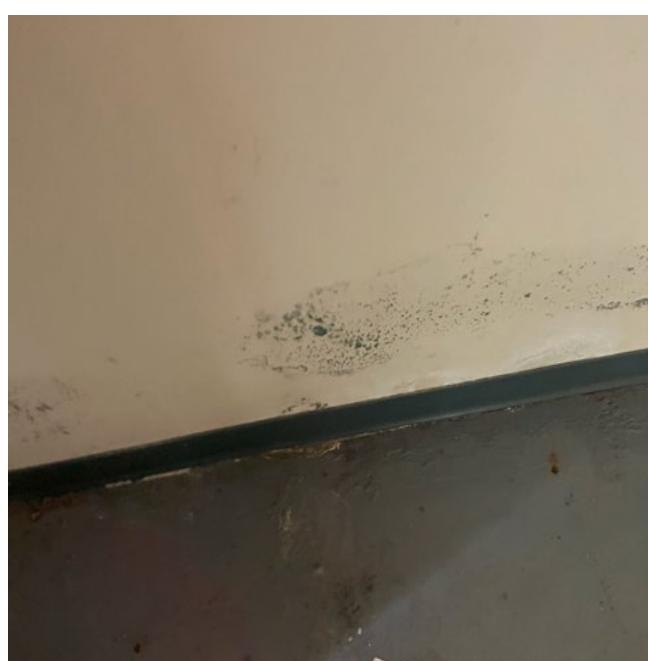
<p>Location: Basement</p> <p>Observation: Approximately 320 SF of visible microbial growth was identified on drywall walls in basement.</p>

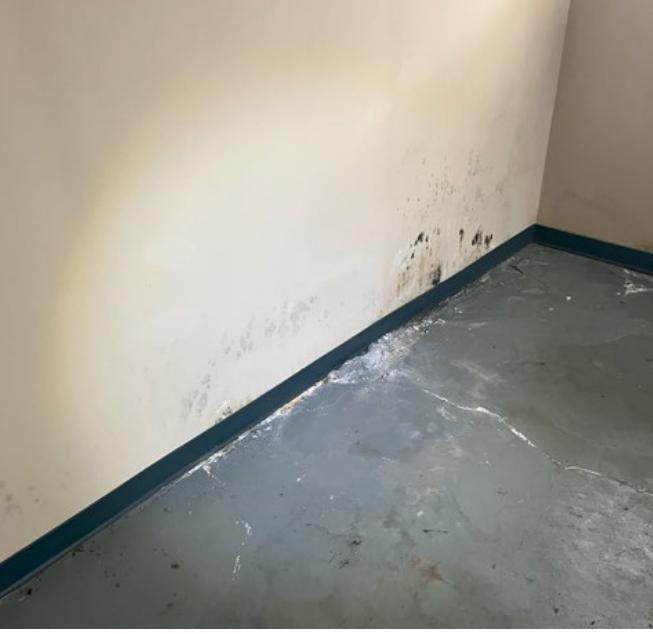
<p>Location: Basement</p> <p>Observation: Approximately 320 SF of visible microbial growth was identified on drywall walls in basement.</p>

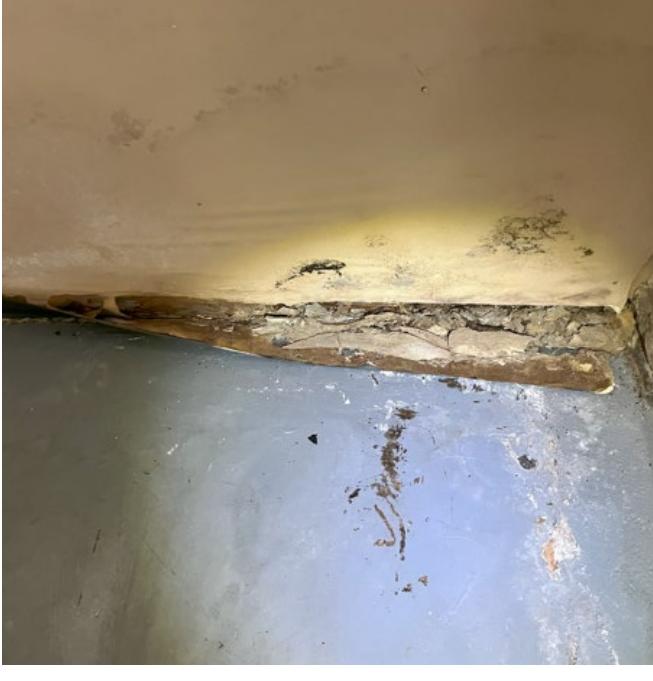
<p>Location: Basement</p> <p>Observation: Approximately 320 SF of visible microbial growth was identified on drywall walls in basement.</p>
