Limited Pre Renovation Hazardous Materials Inspection Report

Asbestos, Lead-Based Paint, & Visual Mold

103 Humboldt Parkway
Buffalo, New York 14214

Project ID: 25-0521DB-A

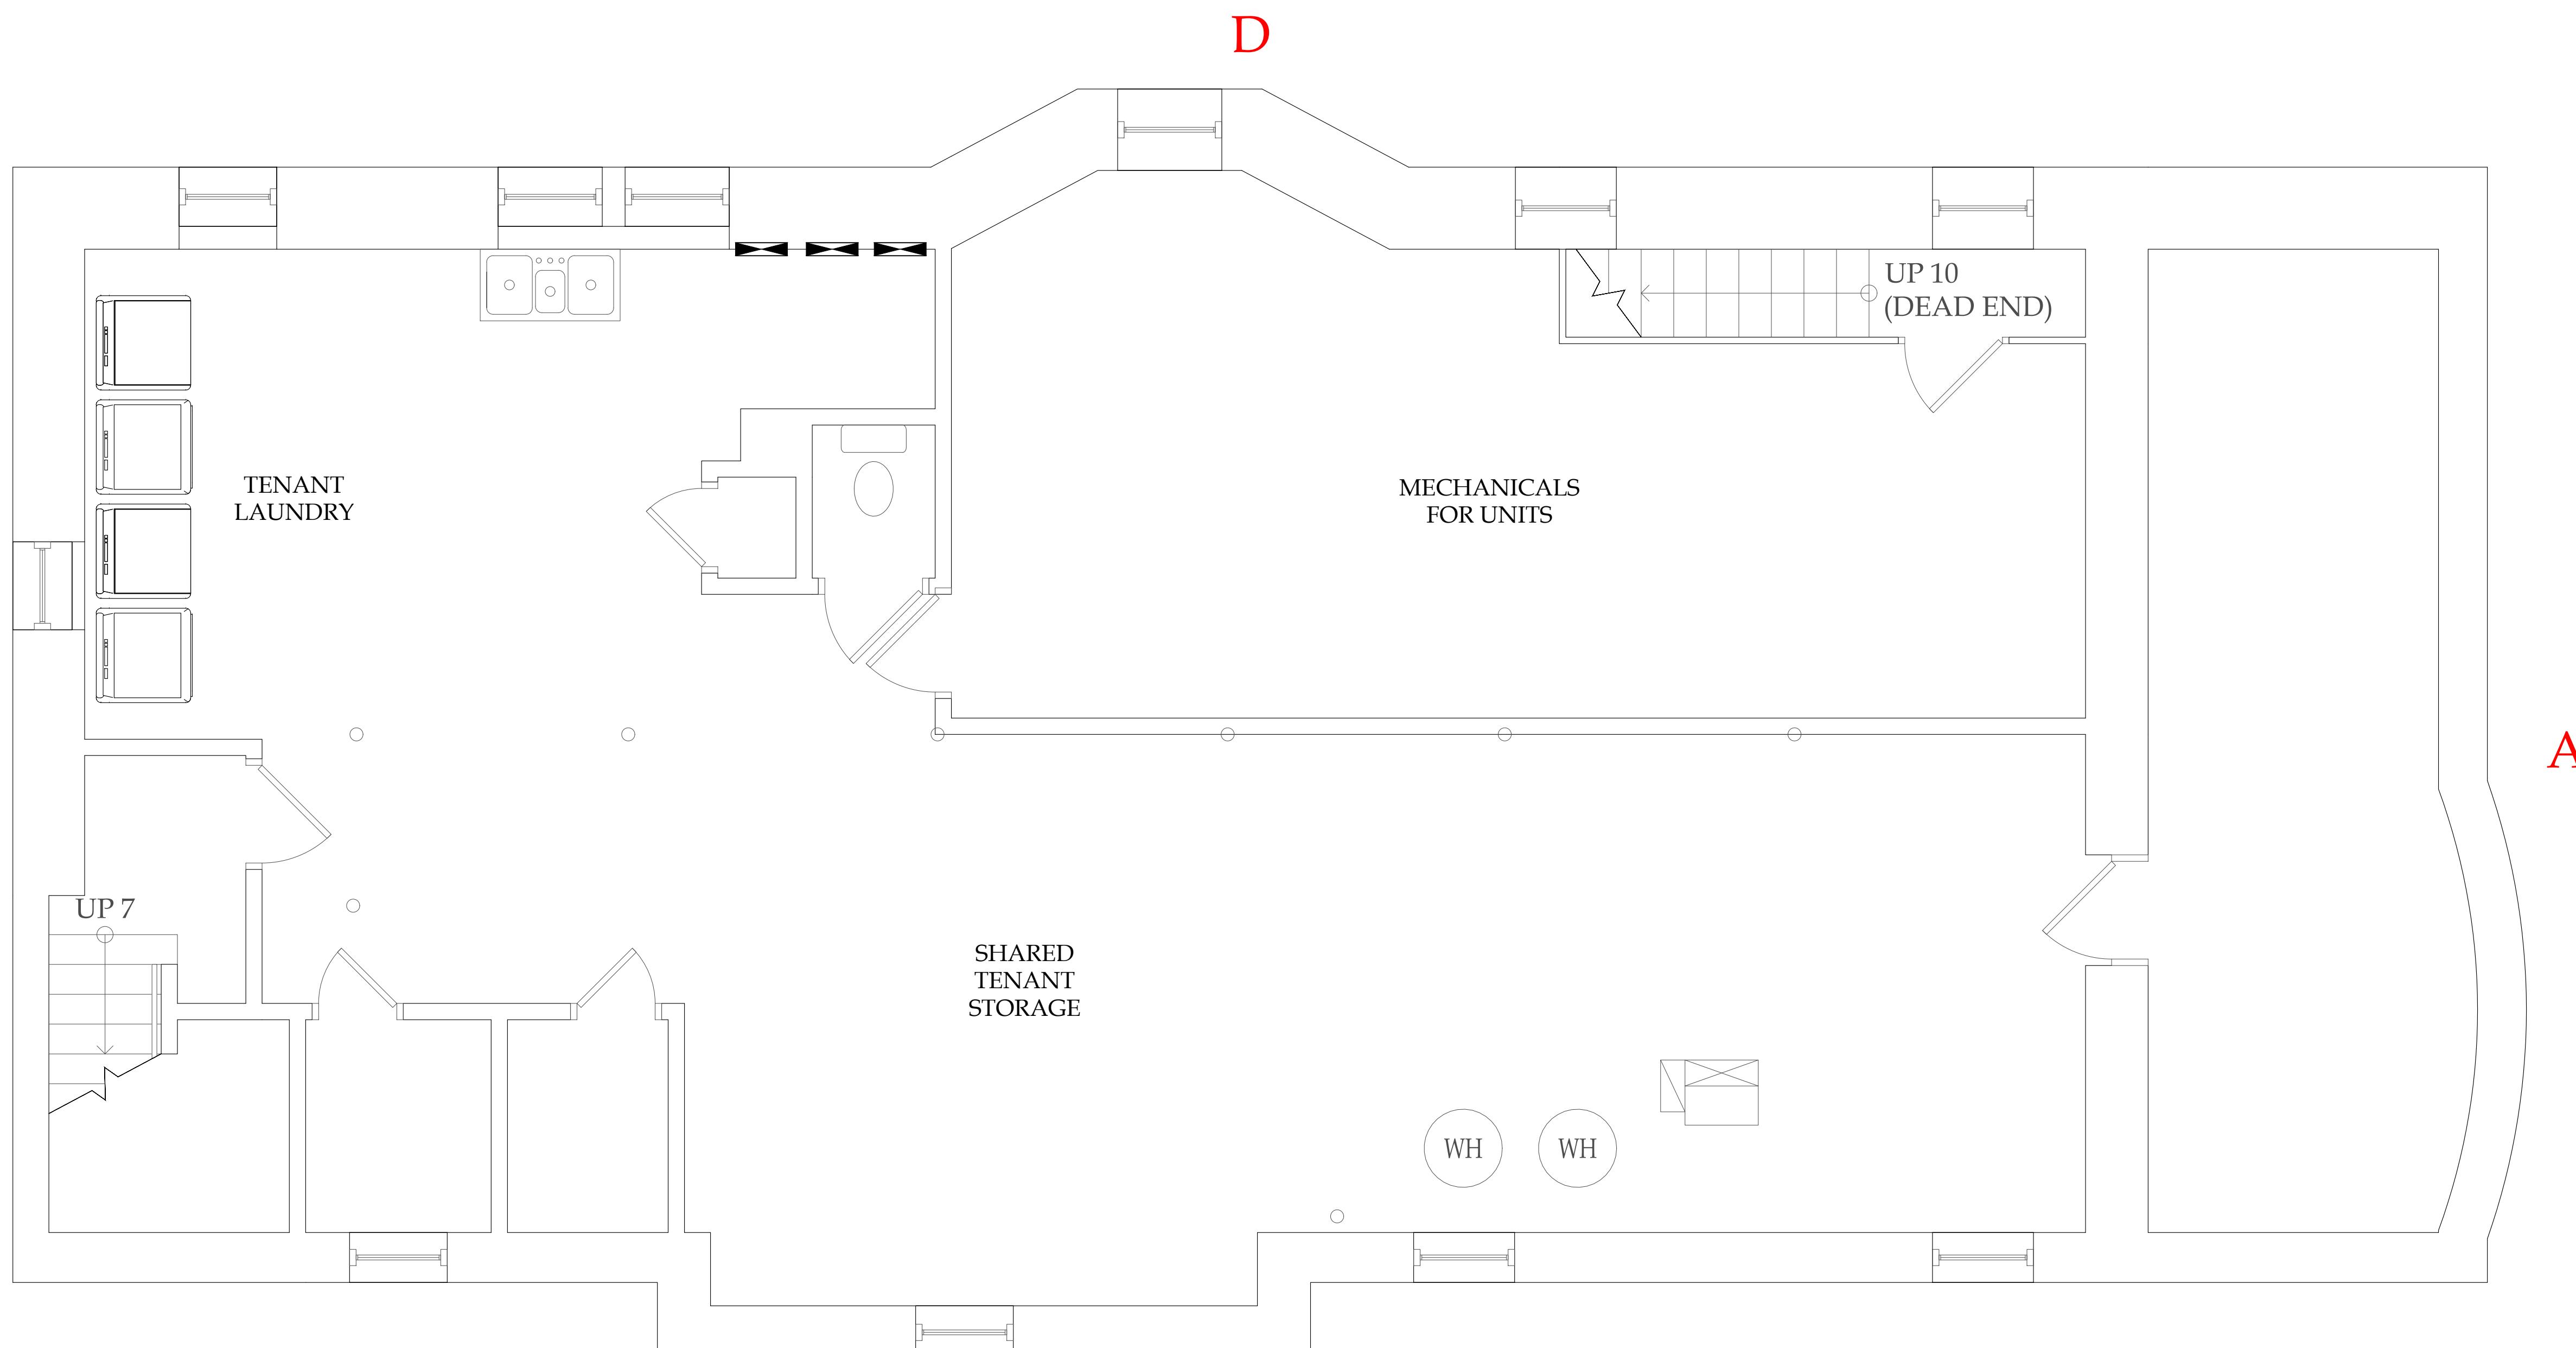
DRAWING #: A-100

A1 PROPOSED BASEMENT PLAN
SCALE: 3/8" = 1'-0"

103 HUMBOLDT PARKWAY		
UNIT 'A'	1 BED, 1 BATH	547 SF
UNIT 'B'	STUDIO	748 SF
UNIT 'C'	1 BED, 1 BATH	649 SF
UNIT 'D'	1 BED, 1 BATH	744 SF
UNIT 'E'	1 BED, 1 BATH	749 SF

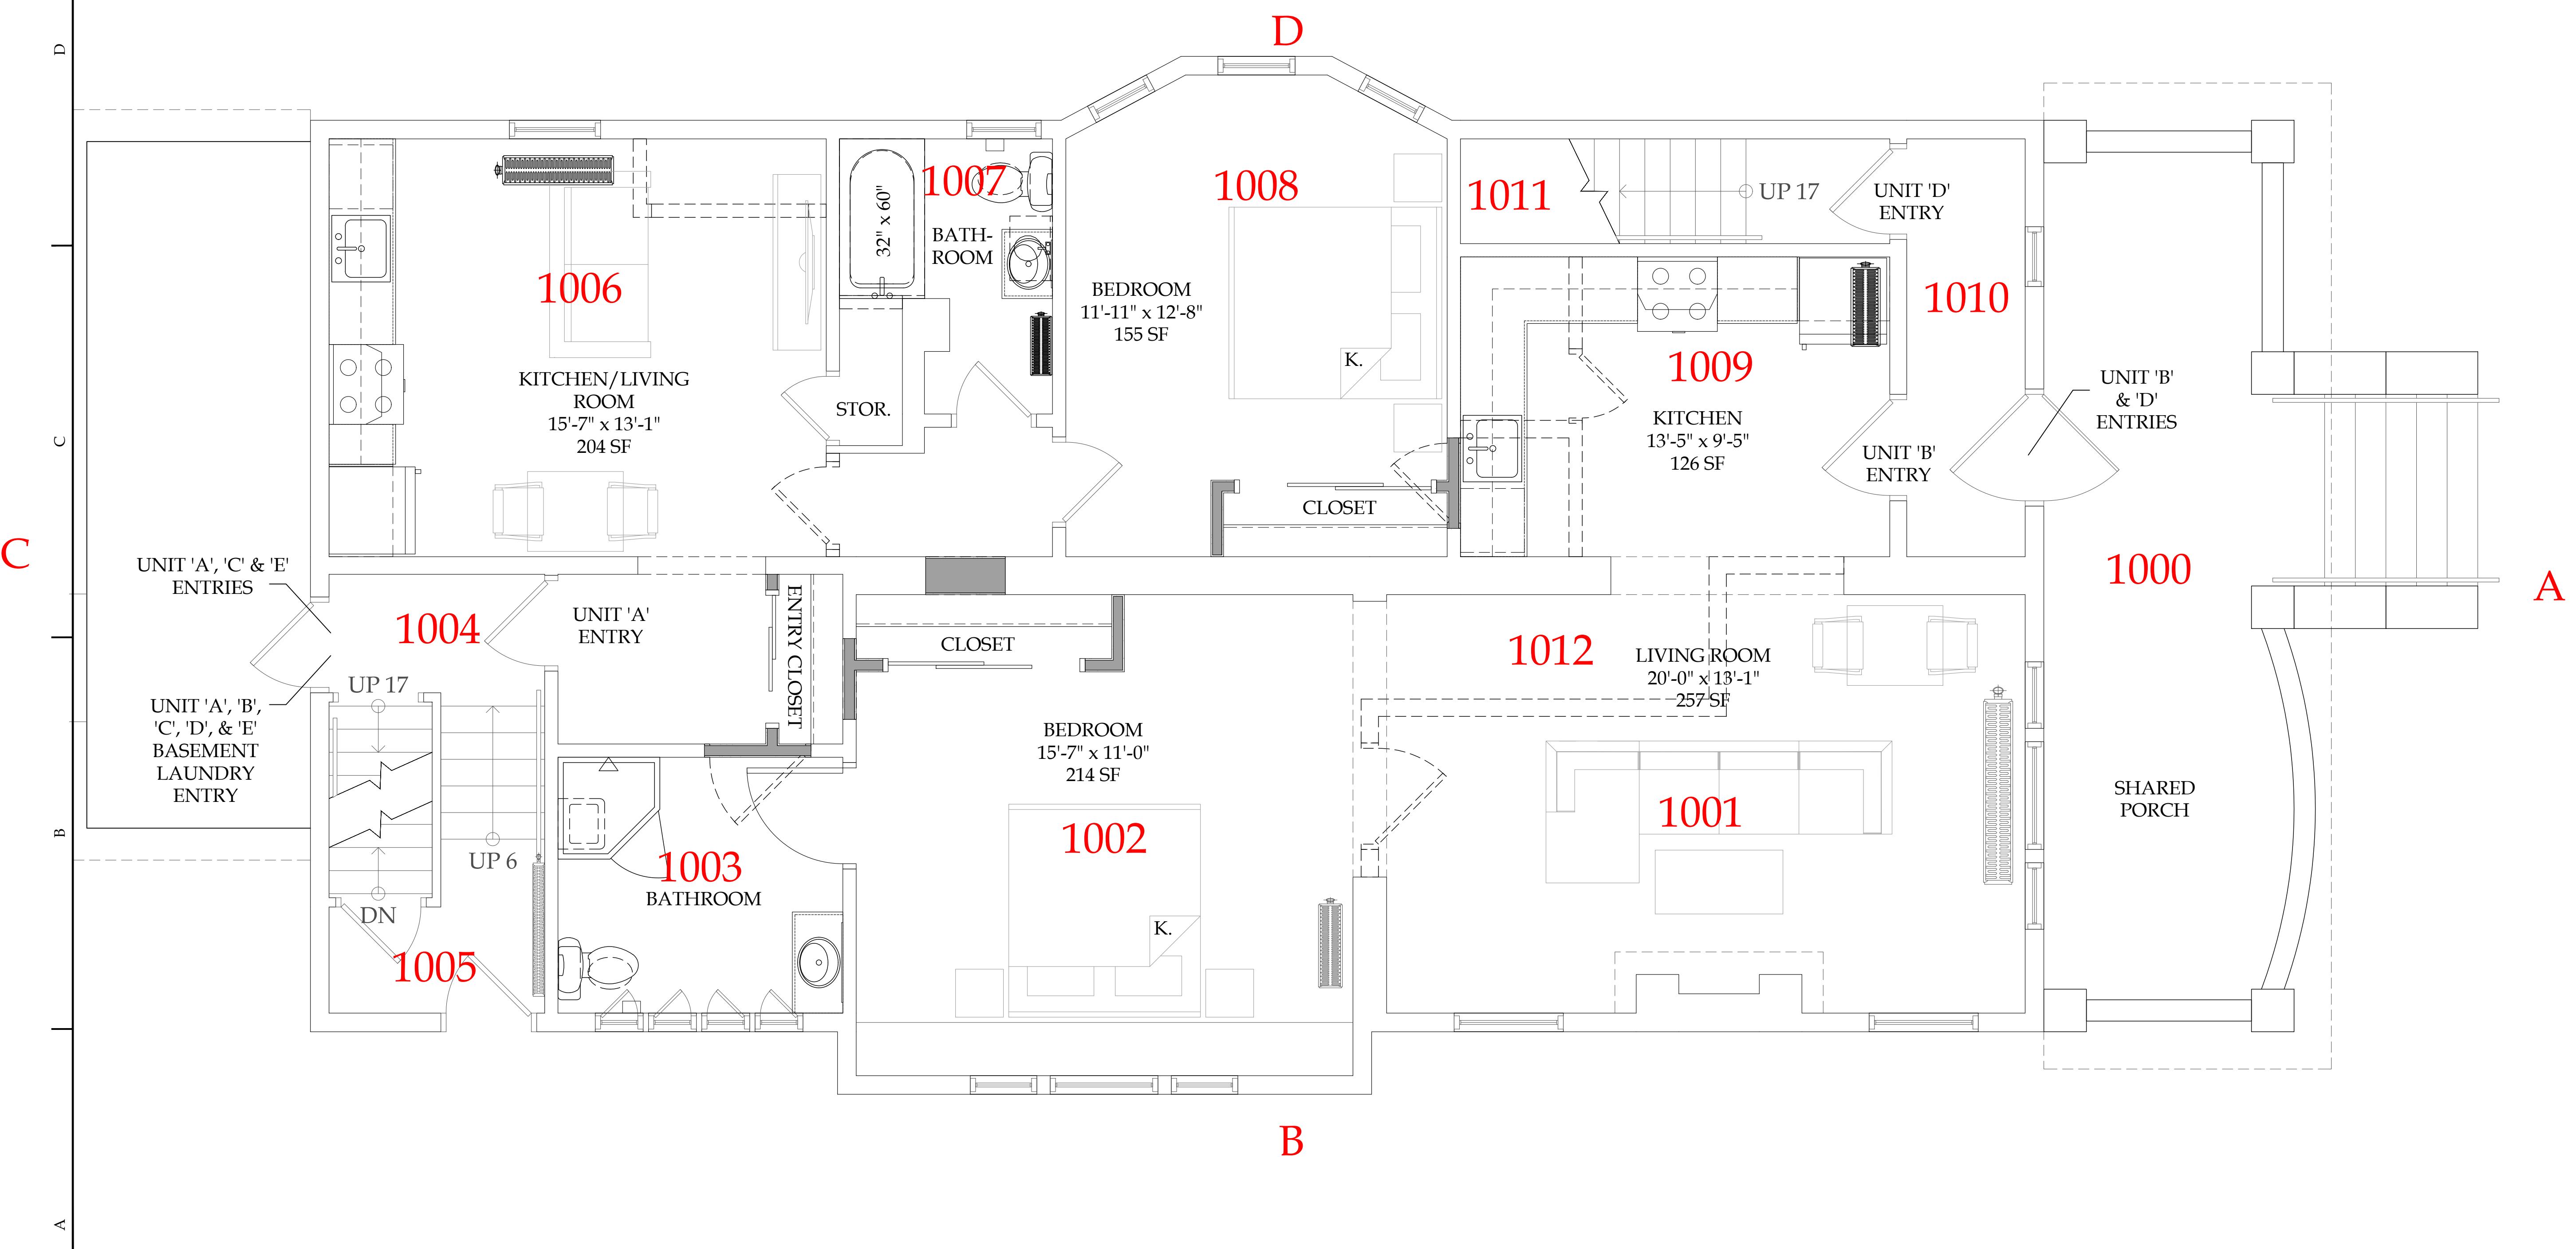
A-101

PROPOSED FIRST FLOOR PLAN

Inspection Key:
0000: Space Identification Denominator
A,B,C,D: Lead Based Paint Directional

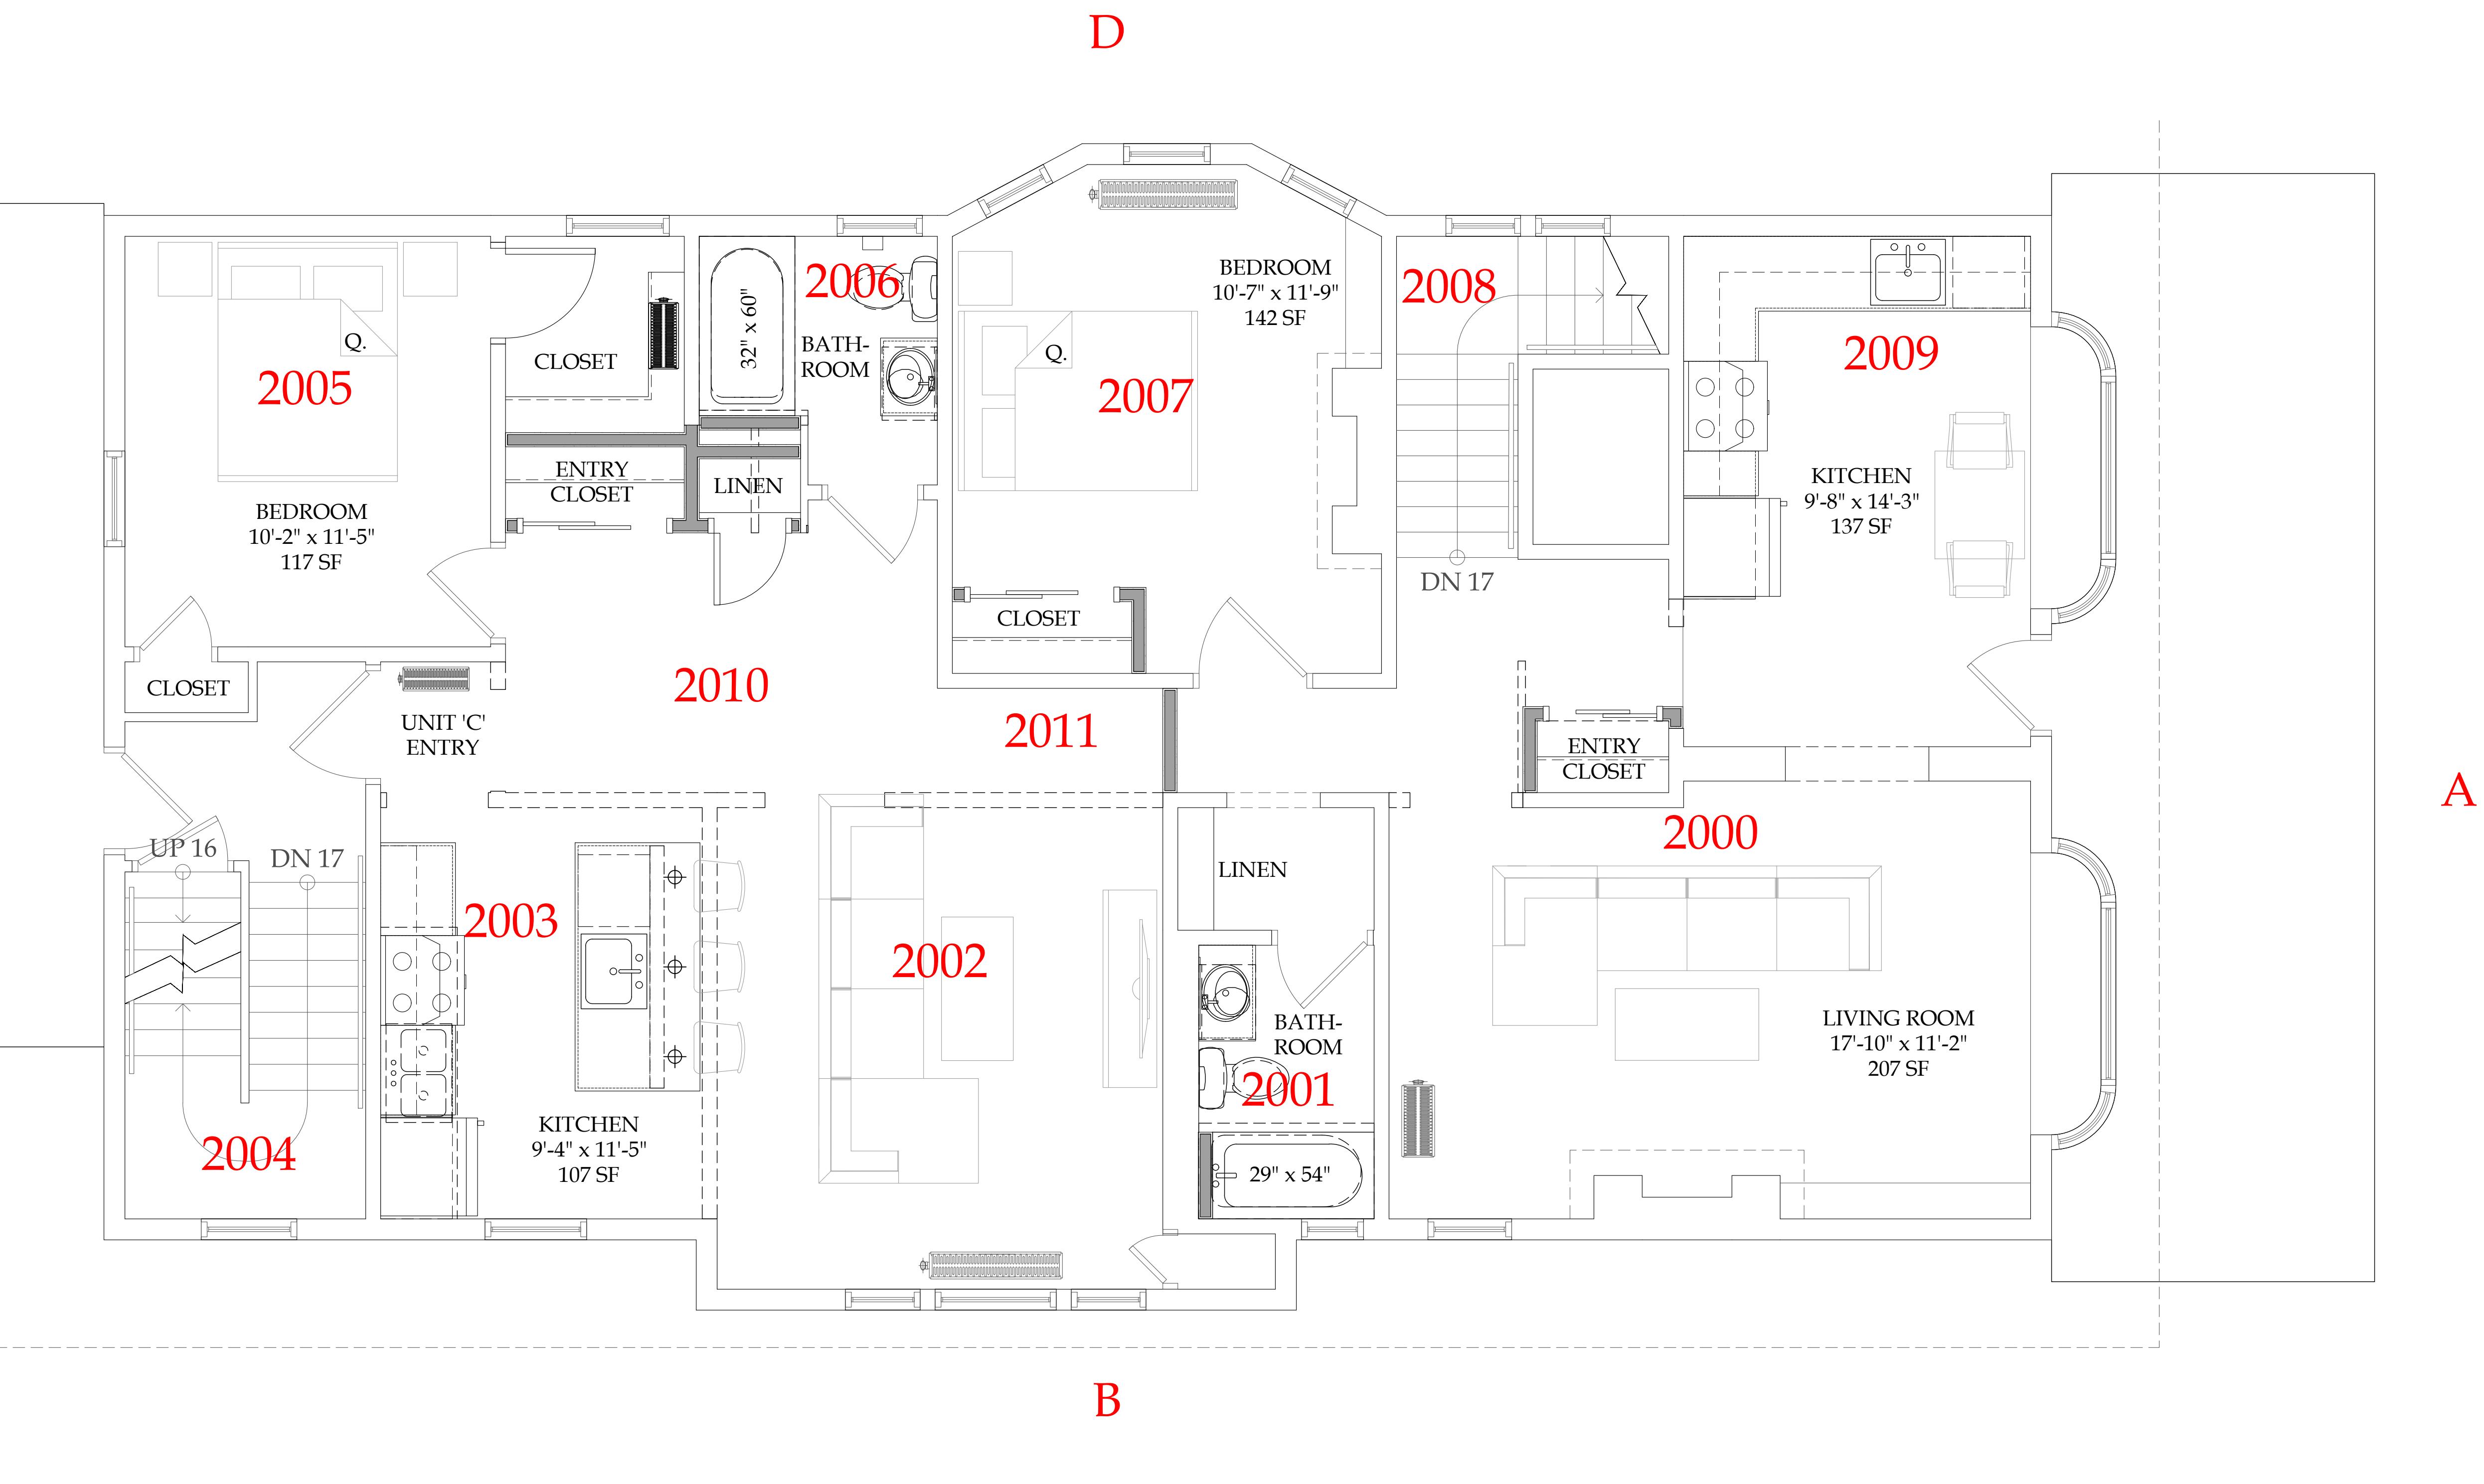
DRAWING #: A-102

PROPOSED SECOND FLOOR PLAN

Inspection Key:
0000: Space Identification Denominator
A,B,C,D: Lead Based Paint Directional

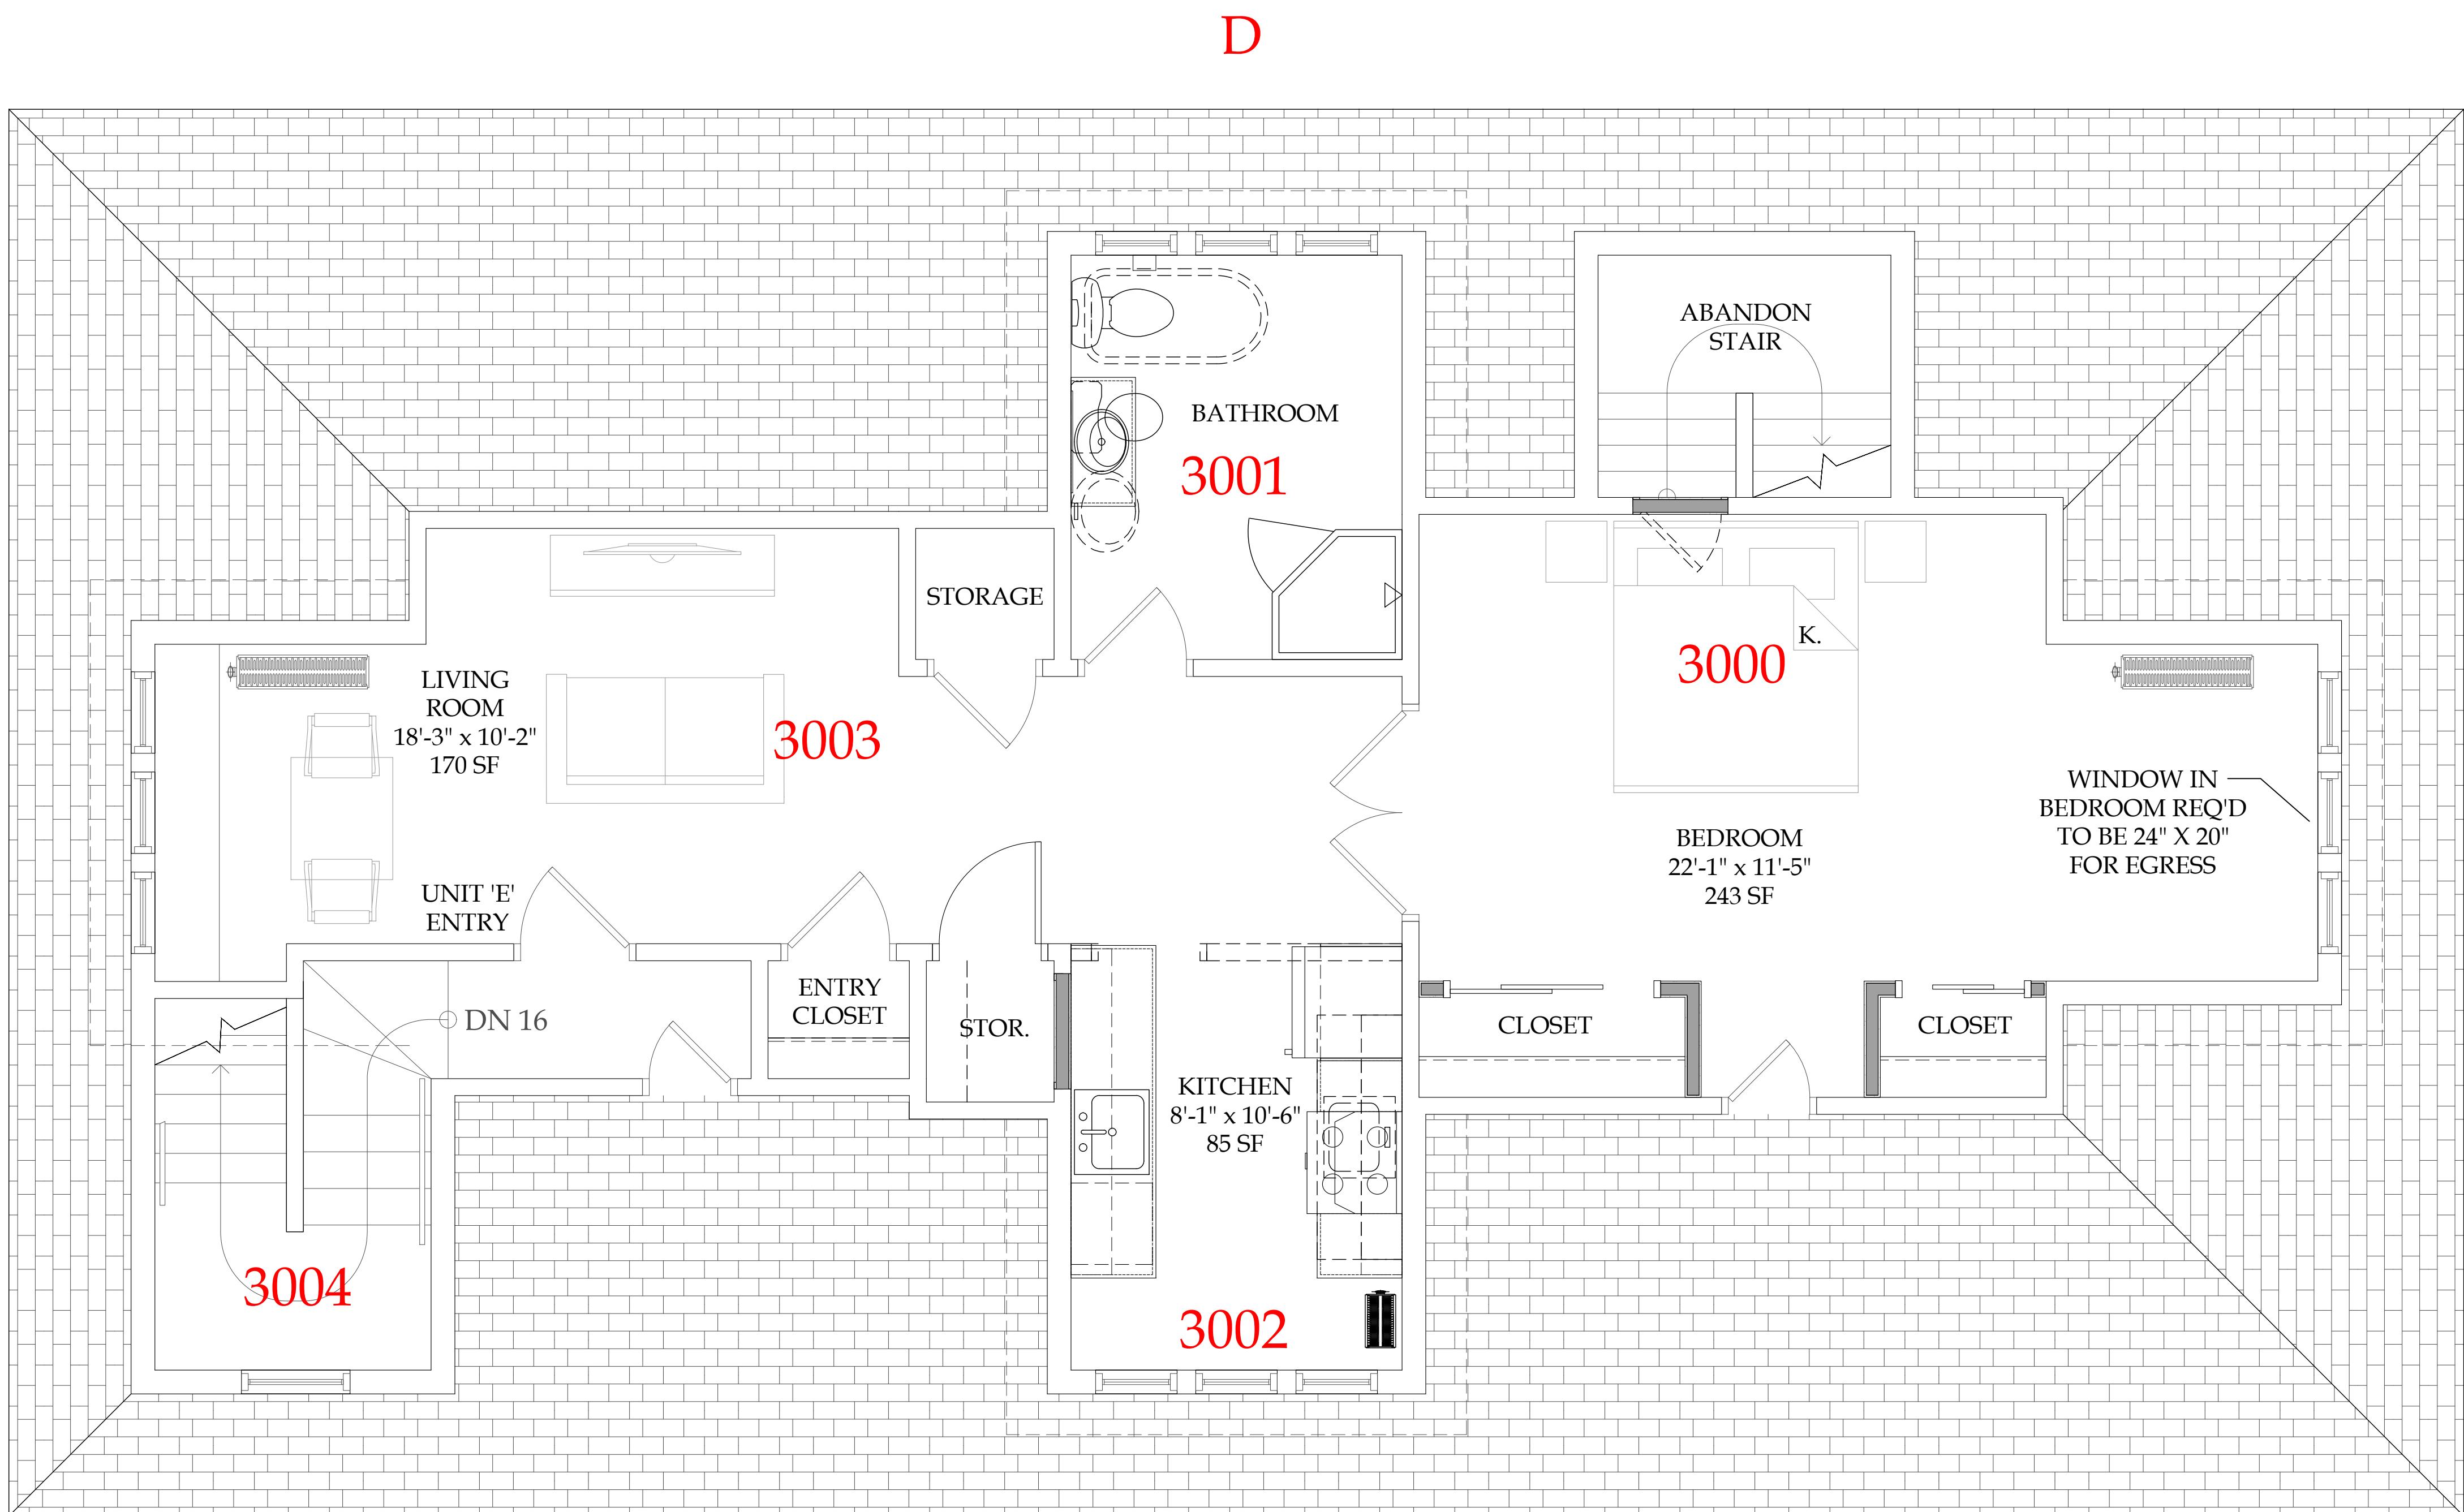
DRAWING #: A-103

PROPOSED THIRD FLOOR PLAN

Inspection Key:
0000: Space Identification Denominator
A,B,C,D: Lead Based Paint Directional

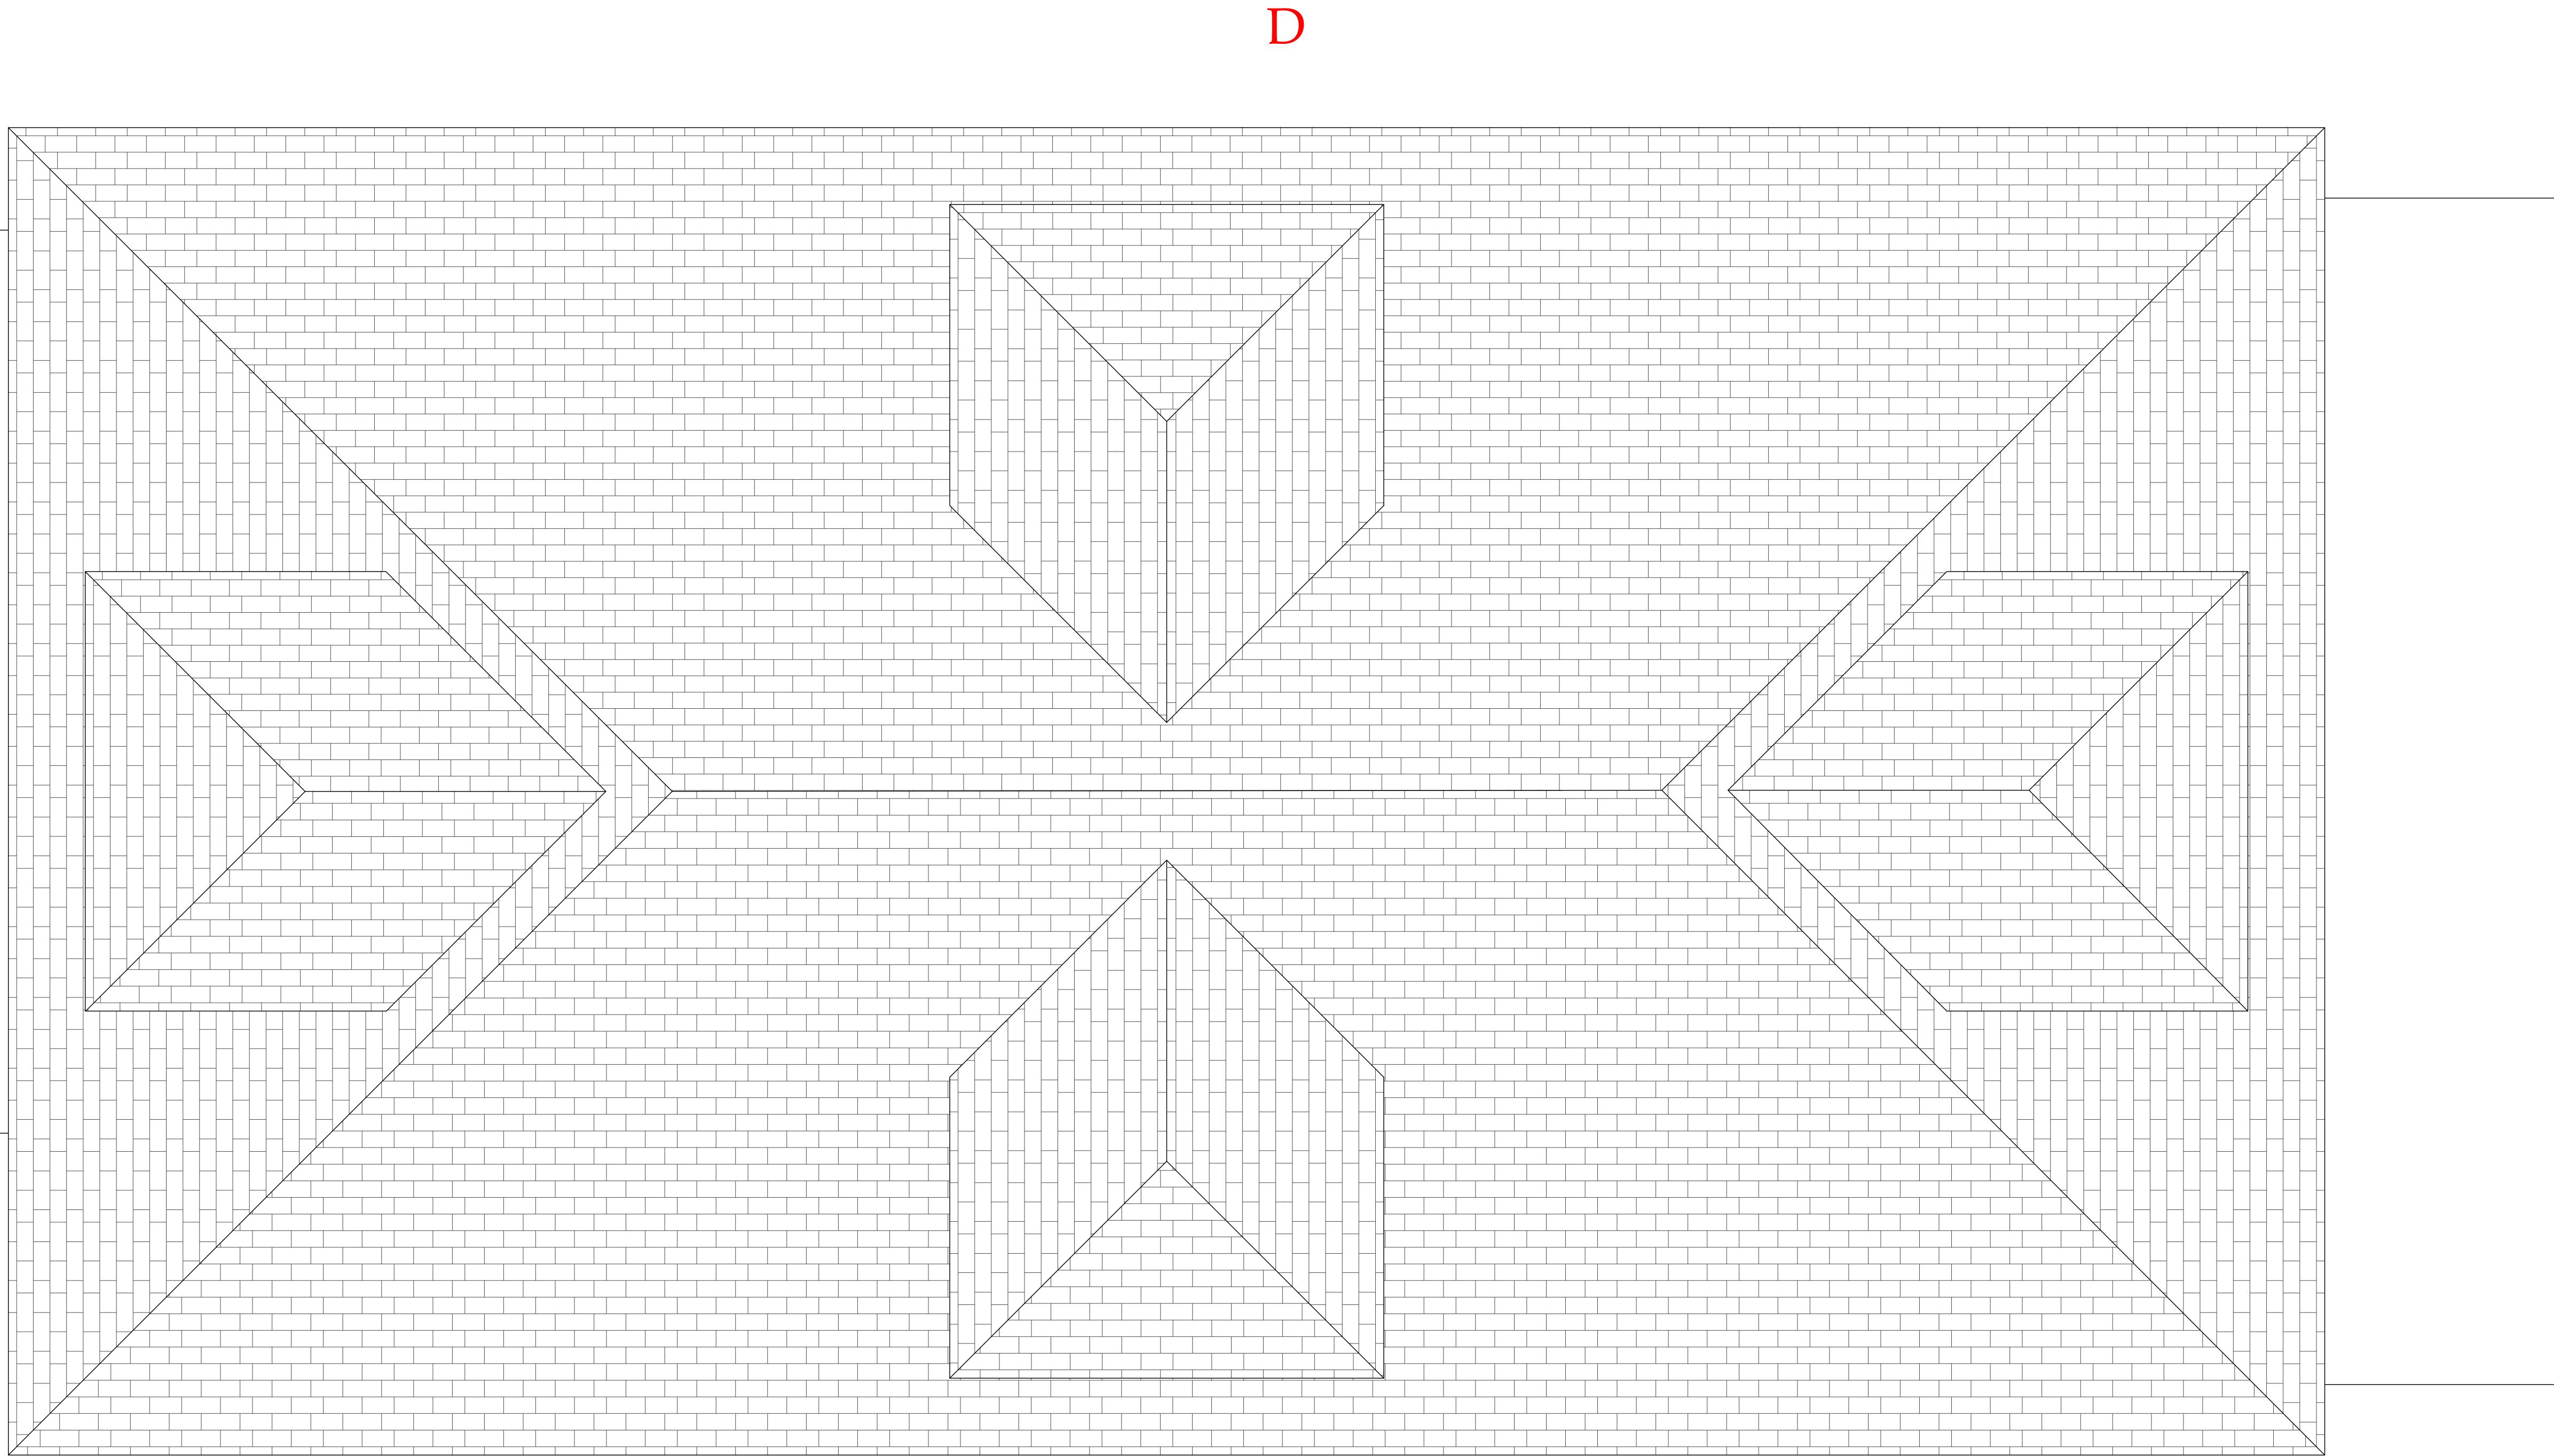
A1 ROOF PLAN
 SCALE: 3/8" = 1'-0"
